HOME REPORT

FLAT 1/1
21 MILLER STREET
CLYDEBANK
G81 1UP

DM HALL
CHARTERED SURVEYORS

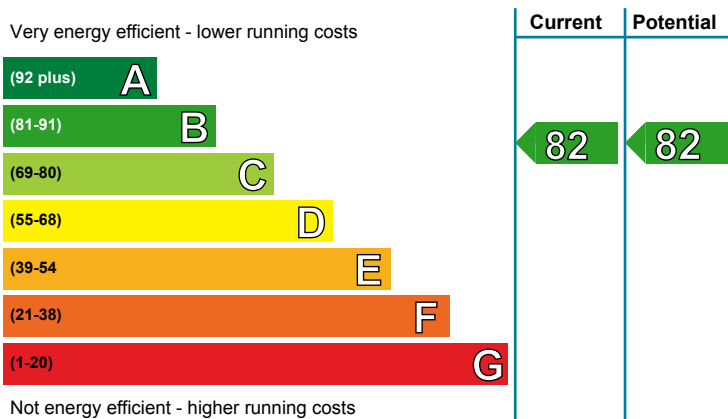
Energy Efficiency Rating

This graph shows the current efficiency of your home, taking into account both energy efficiency and fuel costs. The higher this rating, the lower your fuel bills are likely to be.

Your current rating is **band B (82)**. The average rating for EPCs in Scotland is **band D (61)**.

The potential rating shows the effect of undertaking all of the improvement measures listed within your recommendations report.

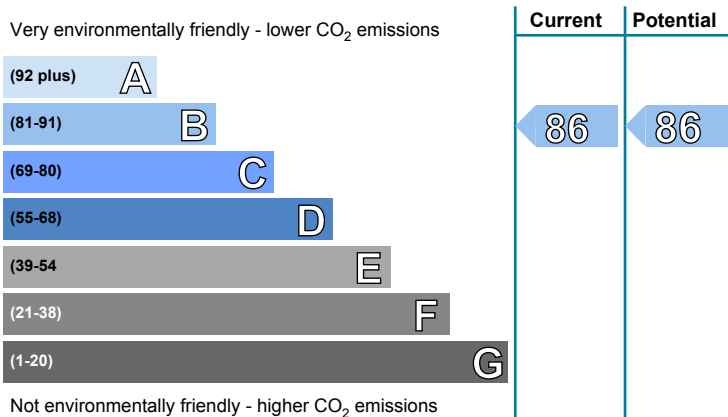
Environmental Impact (CO₂) Rating

This graph shows the effect of your home on the environment in terms of carbon dioxide (CO₂) emissions. The higher the rating, the less impact it has on the environment.

Your current rating is **band B (86)**. The average rating for EPCs in Scotland is **band D (59)**.

The potential rating shows the effect of undertaking all of the improvement measures listed within your recommendations report.
