FLAT 2/4  
164 ST ANDREWS ROAD  
GLASGOW  
G41 1PG

# Home Report

# Energy Performance Certificate

# Scottish Single Survey

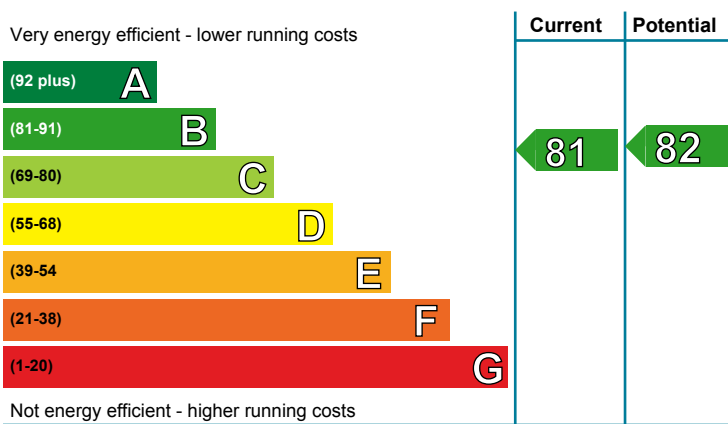
## Energy Efficiency Rating

This graph shows the current efficiency of your home, taking into account both energy efficiency and fuel costs. The higher this rating, the lower your fuel bills are likely to be.

Your current rating is **band B (81)**. The average rating for EPCs in Scotland is **band D (61)**.

The potential rating shows the effect of undertaking all of the improvement measures listed within your recommendations report.

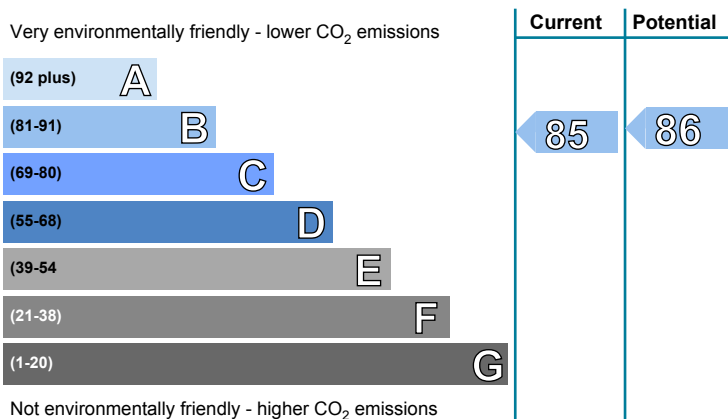
## Environmental Impact (CO<sub>2</sub>) Rating

This graph shows the effect of your home on the environment in terms of carbon dioxide (CO<sub>2</sub>) emissions. The higher the rating, the less impact it has on the environment.

Your current rating is **band B (85)**. The average rating for EPCs in Scotland is **band D (59)**.

The potential rating shows the effect of undertaking all of the improvement measures listed within your recommendations report.
