136 LOCH ROAD
KIRKINTILLOCH
GLASGOW
G66 3EA

Home Report

136 LOCH ROAD, KIRKINTILLOCH, GLASGOW, G66 3EA

Scottish Single Survey

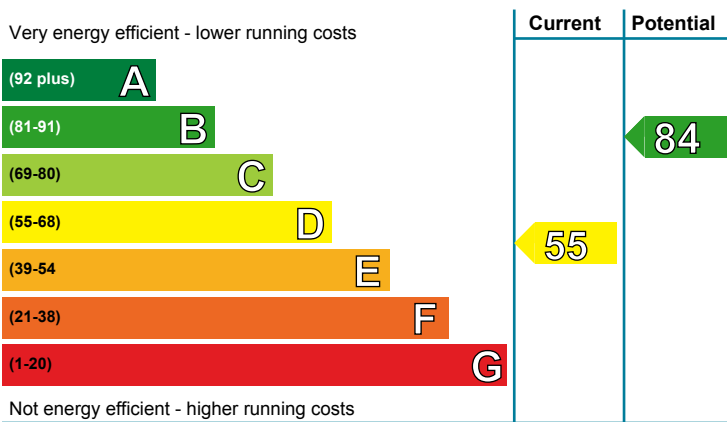
Energy Efficiency Rating

This graph shows the current efficiency of your home, taking into account both energy efficiency and fuel costs. The higher this rating, the lower your fuel bills are likely to be.

Your current rating is **band D (55)**. The average rating for EPCs in Scotland is **band D (61)**.

The potential rating shows the effect of undertaking all of the improvement measures listed within your recommendations report.

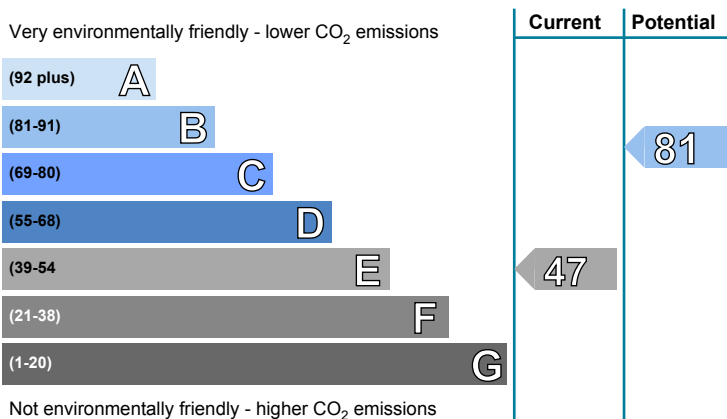
Environmental Impact (CO₂) Rating

This graph shows the effect of your home on the environment in terms of carbon dioxide (CO₂) emissions. The higher the rating, the less impact it has on the environment.

Your current rating is **band E (47)**. The average rating for EPCs in Scotland is **band D (59)**.

The potential rating shows the effect of undertaking all of the improvement measures listed within your recommendations report.
