FLAT 2/3
122 VICTORIA ROAD
GLASGOW
G42 7JD

Home Report

Scottish Single Survey

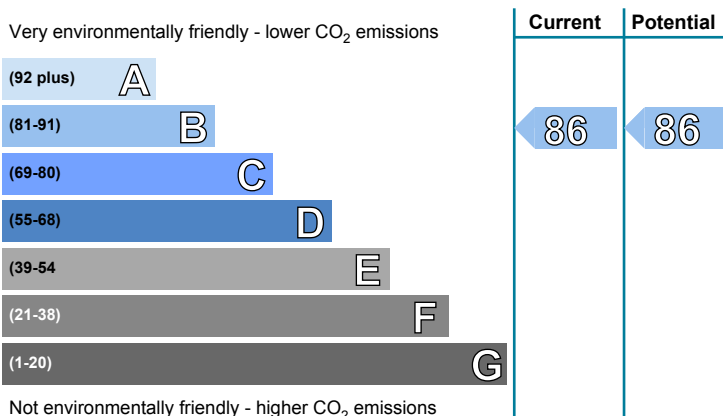
Environmental Impact (CO₂) Rating

This graph shows the effect of your home on the environment in terms of carbon dioxide (CO₂) emissions. The higher the rating, the less impact it has on the environment.

Your current rating is **band B (86)**. The average rating for EPCs in Scotland is **band D (59)**.

The potential rating shows the effect of undertaking all of the improvement measures listed within your recommendations report.
