FLAT 2/2  
50 CRAIGIE STREET  
GLASGOW  
G42 8NH

# Home Report

**Dwelling type:** Mid-floor flat  
**Date of assessment:** 25 April 2022  
**Date of certificate:** 26 April 2022  
**Total floor area:** 44 m<sup>2</sup>  
**Primary Energy Indicator:** 245 kWh/m<sup>2</sup>/year

# Scottish Single Survey

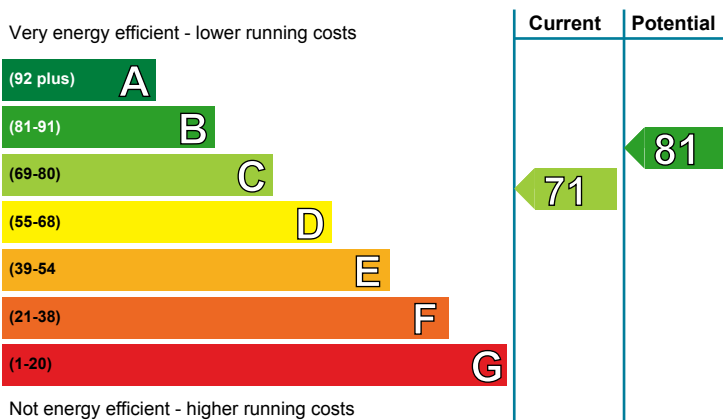
## Energy Efficiency Rating

This graph shows the current efficiency of your home, taking into account both energy efficiency and fuel costs. The higher this rating, the lower your fuel bills are likely to be.

Your current rating is **band C (71)**. The average rating for EPCs in Scotland is **band D (61)**.

The potential rating shows the effect of undertaking all of the improvement measures listed within your recommendations report.

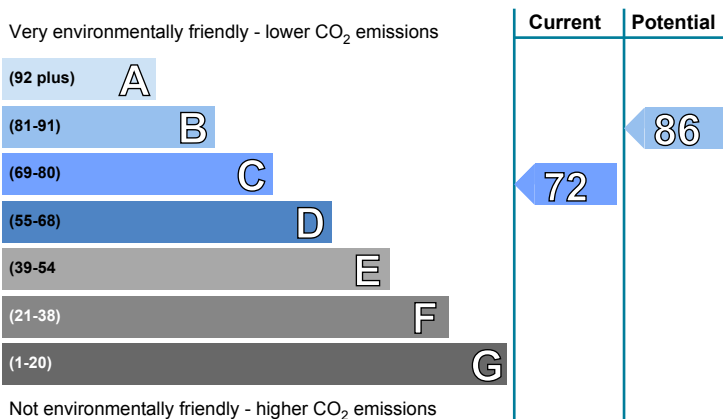
## Environmental Impact (CO<sub>2</sub>) Rating

This graph shows the effect of your home on the environment in terms of carbon dioxide (CO<sub>2</sub>) emissions. The higher the rating, the less impact it has on the environment.

Your current rating is **band C (72)**. The average rating for EPCs in Scotland is **band D (59)**.

The potential rating shows the effect of undertaking all of the improvement measures listed within your recommendations report.
