survey report on:

52 Strathblane Gardens, Glasgow, G13 1BX
--

PART 1 - GENERAL

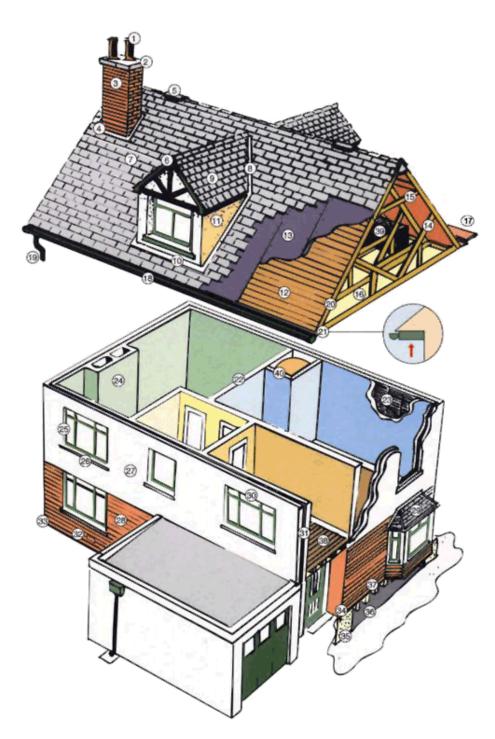
Sectional Diagram showing elements of a typical house

Reference may be made in this report to some or all of the above component parts of the property. This diagram may assist you in locating and understanding these items.

- 1) Chimney pots
- 2) Coping stone
- 3) Chimney head
- 4 Flashing
- 5 Ridge ventilation
- 6 Ridge board
- 7) Slates / tiles
- 8 Valley guttering
- 9 Dormer projection
- 10) Dormer flashing
- 11) Dormer cheeks
- 12) Sarking
- (13) Roof felt
- (14) Trusses
- (15) Collar
- 16 Insulation
- 17) Parapet gutter
- 18) Eaves guttering
- 19) Rainwater downpipe
- 20) Verge boards/skews
- 21) Soffit boards
- 22) Partition wall
- 23) Lath / plaster
- 24) Chimney breast
- 25) Window pointing
- 6) Window sills
- 27) Rendering
- (28) Brickwork / pointing
- 29) Bay window projection
- 30 Lintels
- (31) Cavity walls / wall ties
- 32) Subfloor ventilator
- 33 Damp proof course
- 34) Base course
- 35) Foundations
- (36) Solum
- 37) Floor joists
- 38) Floorboards
- 39) Water tank
- 40) Hot water tank
