# Home Report

# Single Survey

<b>Property address</b>	9 Church View Coatbridge ML5 3BE
<b>Customer</b>	Mr M Travers
<b>Customer address</b>	9 Church View Coatbridge ML5 3BE
<b>Prepared by</b>	Shepherd Chartered Surveyors
<b>Date of inspection</b>	26/02/2024

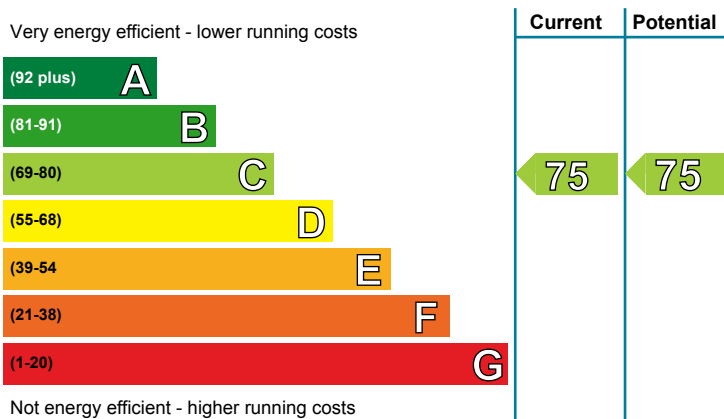
## Energy Efficiency Rating

This graph shows the current efficiency of your home, taking into account both energy efficiency and fuel costs. The higher this rating, the lower your fuel bills are likely to be.

Your current rating is **band C (75)**. The average rating for EPCs in Scotland is **band D (61)**.

The potential rating shows the effect of undertaking all of the improvement measures listed within your recommendations report.

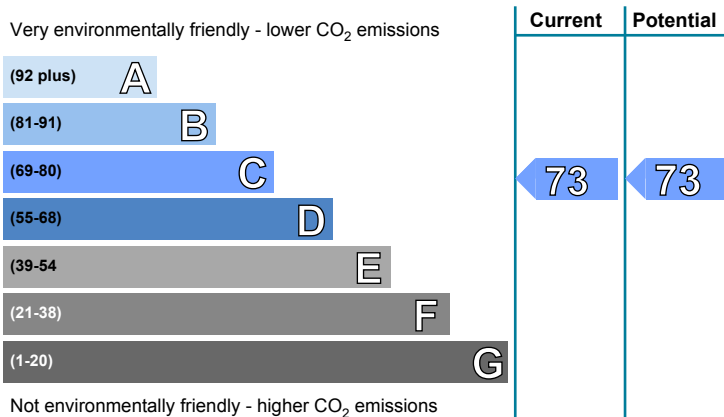
## Environmental Impact (CO<sub>2</sub>) Rating

This graph shows the effect of your home on the environment in terms of carbon dioxide (CO<sub>2</sub>) emissions. The higher the rating, the less impact it has on the environment.
