FLAT 2  
57 PARTICK BRIDGE STREET  
GLASGOW  
G11 6PQ

# Home Report

FLAT 2 , 57 PARTICK BRIDGE STREET, GLASGOW, G11 6PQ

# Scottish Single Survey

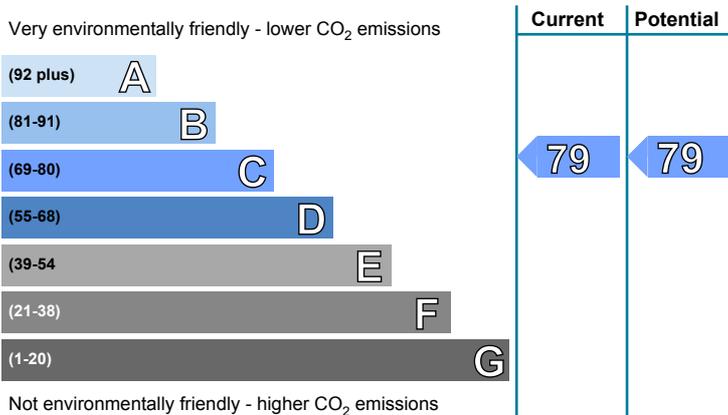
## Environmental Impact (CO<sub>2</sub>) Rating

This graph shows the effect of your home on the environment in terms of carbon dioxide (CO<sub>2</sub>) emissions. The higher the rating, the less impact it has on the environment.

Your current rating is **band C (79)**. The average rating for EPCs in Scotland is **band D (59)**.

The potential rating shows the effect of undertaking all of the improvement measures listed within your recommendations report.
