HOME REPORT

19 BURNTON
DALMELLINGTON
AYR
KA6 7RY

Energy Performance Certificate (EPC)

Single Survey

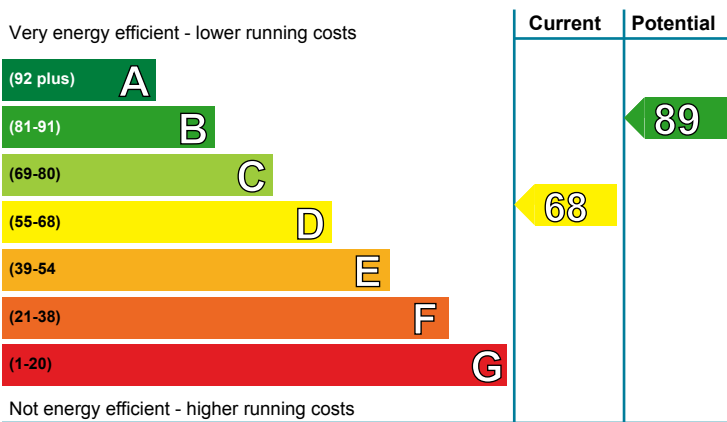
Energy Efficiency Rating

This graph shows the current efficiency of your home, taking into account both energy efficiency and fuel costs. The higher this rating, the lower your fuel bills are likely to be.

Your current rating is **band D (68)**. The average rating for EPCs in Scotland is **band D (61)**.

The potential rating shows the effect of undertaking all of the improvement measures listed within your recommendations report.
