259 HAWICK STREET
GLASGOW
G13 4HF

Home Report

259 HAWICK STREET, GLASGOW, G13 4HF

Dwelling type: Mid-terrace house
Date of assessment: 06 November 2020
Date of certificate: 09 November 2020
Total floor area: 97 m²
Primary Energy Indicator: 227 kWh/m²/year

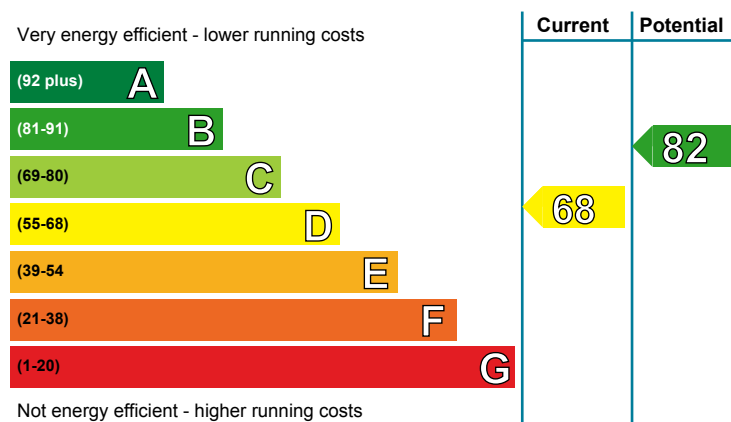
Energy Efficiency Rating

This graph shows the current efficiency of your home, taking into account both energy efficiency and fuel costs. The higher this rating, the lower your fuel bills are likely to be.

Your current rating is **band D (68)**. The average rating for EPCs in Scotland is **band D (61)**.

The potential rating shows the effect of undertaking all of the improvement measures listed within your recommendations report.

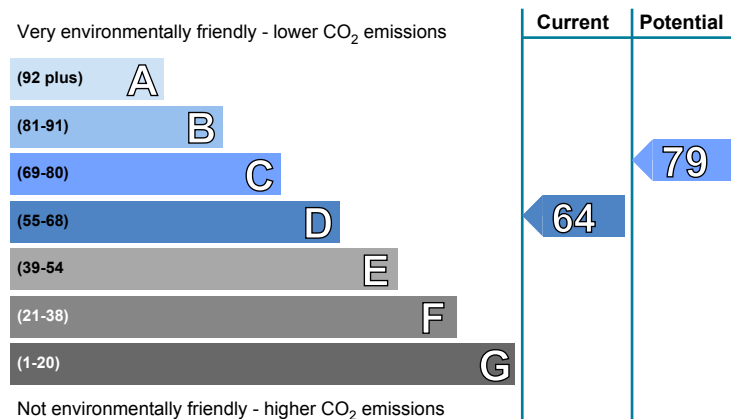
Environmental Impact (CO₂) Rating

This graph shows the effect of your home on the environment in terms of carbon dioxide (CO₂) emissions. The higher the rating, the less impact it has on the environment.

Your current rating is **band D (64)**. The average rating for EPCs in Scotland is **band D (59)**.

The potential rating shows the effect of undertaking all of the improvement measures listed within your recommendations report.
