Home Report

Scottish Single Survey

Property address	1/1 8 Allison Street Glasgow G42 8NN
-------------------------	---

Prepared by	Shepherd Chartered Surveyors
--------------------	------------------------------

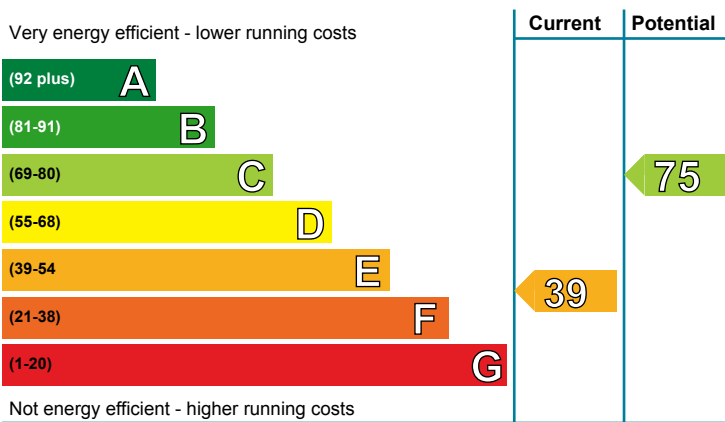
Energy Efficiency Rating

This graph shows the current efficiency of your home, taking into account both energy efficiency and fuel costs. The higher this rating, the lower your fuel bills are likely to be.

Your current rating is **band E (39)**. The average rating for EPCs in Scotland is **band D (61)**.

The potential rating shows the effect of undertaking all of the improvement measures listed within your recommendations report.

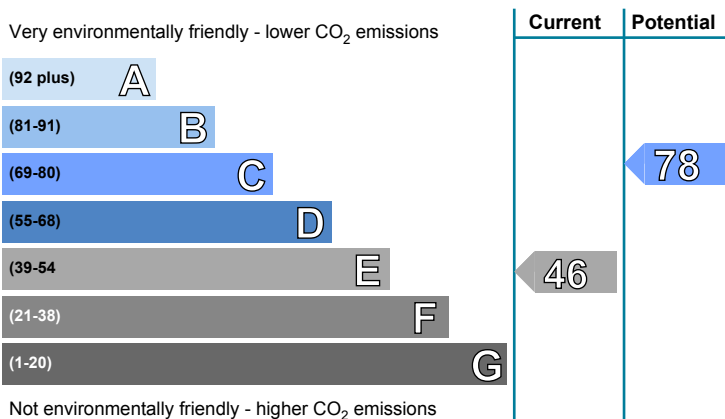
Environmental Impact (CO₂) Rating

This graph shows the effect of your home on the environment in terms of carbon dioxide (CO₂) emissions. The higher the rating, the less impact it has on the environment.
