# **HOME REPORT**

FLAT 1/2 13 HAIRST STREET RENFREW PA4 8QU

# SINGLE SURVEY

## survey report on:

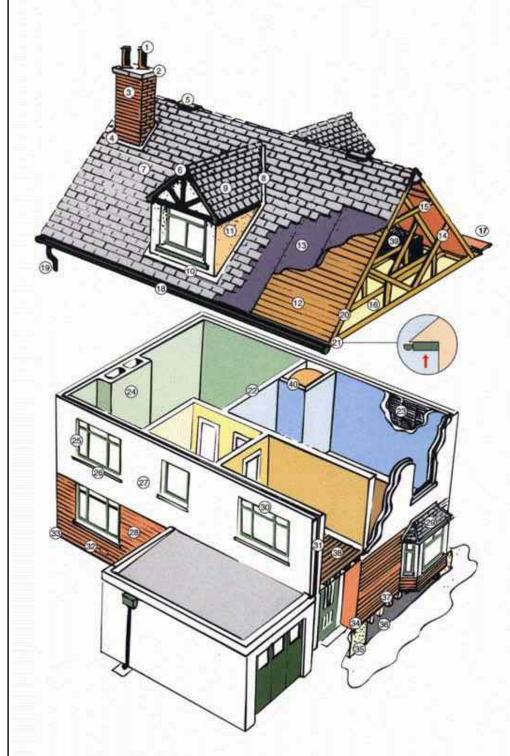
#### Sectional Diagram showing elements of a typical house

Reference may be made in this report to some or all of the above component parts of the property. This diagram may assist you in locating and understanding these items.

- 1) Chimney pots
- (2) Coping stone
- 3) Chimney head
- 4 Flashing
- (5) Ridge ventilation
- 6) Ridge board
- 7) Slates / tiles
- (8) Valley guttering
- 9 Dormer projection
- (10) Dormer flashing
- 11) Dormer cheeks
- 12) Sarking
- 13) Roof felt
- (14) Trusses
- 15) Collar
- (16) Insulation
- 17) Parapet gutter
- 18) Eaves guttering
- 19) Rainwater downpipe
- 0) Verge boards /skews
- 21) Soffit boards
- 22) Partition wall
- 3 Lath / plaster
- 24) Chimney breast
- (25) Window pointing
- S .....
- 26) Window sills
- (27) Rendering
- (28) Brickwork / pointing
- (29) Bay window projection
- (30) Lintels
- (31) Cavity walls / wall ties
- 32) Subfloor ventilator
- 33) Damp proof course
- 34) Base course
- 35) Foundations
- 36) Solum
- 37) Floor joists
- 8) Floorboards
- 9) Water tank
- 40) Hot water tank
