FLAT 2/2  
24 THORNWOOD ROAD  
GLASGOW  
G11 7RB

# Home Report

FLAT 2/2 , 24 THORNWOOD ROAD, GLASGOW, G11 7RB

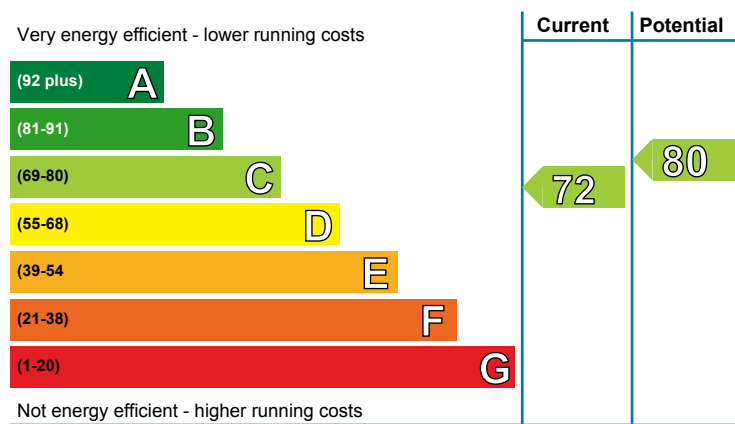
## Energy Efficiency Rating

This graph shows the current efficiency of your home, taking into account both energy efficiency and fuel costs. The higher this rating, the lower your fuel bills are likely to be.

Your current rating is **band C (72)**. The average rating for EPCs in Scotland is **band D (61)**.

The potential rating shows the effect of undertaking all of the improvement measures listed within your recommendations report.

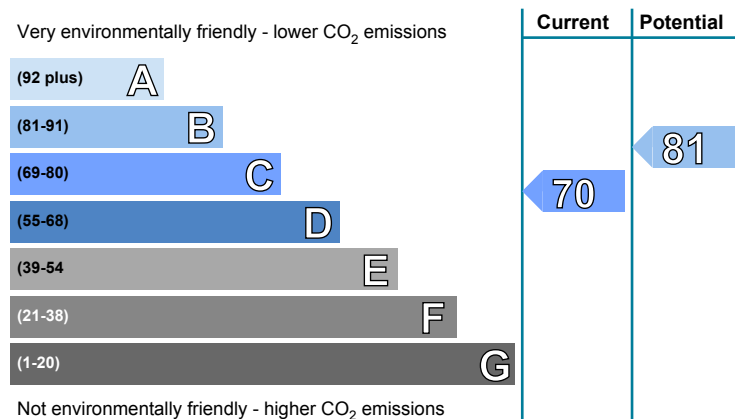
## Environmental Impact (CO<sub>2</sub>) Rating

This graph shows the effect of your home on the environment in terms of carbon dioxide (CO<sub>2</sub>) emissions. The higher the rating, the less impact it has on the environment.

Your current rating is **band C (70)**. The average rating for EPCs in Scotland is **band D (59)**.

The potential rating shows the effect of undertaking all of the improvement measures listed within your recommendations report.
