FLAT 1/1  
18 WHITEFIELD ROAD  
GLASGOW  
G51 2YD

# Home Report

# Energy Performance Certificate

# Scottish Single Survey

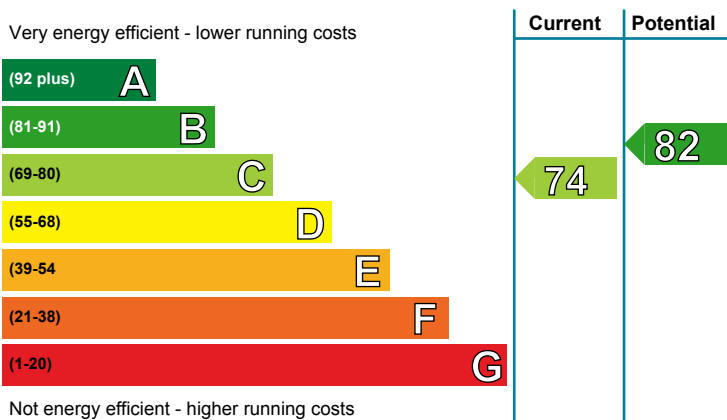
## Energy Efficiency Rating

This graph shows the current efficiency of your home, taking into account both energy efficiency and fuel costs. The higher this rating, the lower your fuel bills are likely to be.

Your current rating is **band C (74)**. The average rating for EPCs in Scotland is **band D (61)**.

The potential rating shows the effect of undertaking all of the improvement measures listed within your recommendations report.
