Home Report

Scottish Single Survey

Property address	2/2 11 Finlay Drive GLASGOW G31 2BD
Customer	Jonathan Tawil
Customer address	2/2 11 Finlay Drive GLASGOW G31 2BD
Prepared by	Shepherd Chartered Surveyors
Date of inspection	29/09/2022

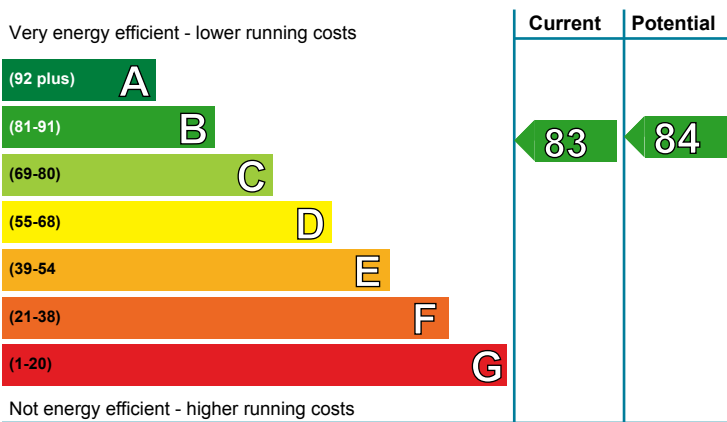
Energy Efficiency Rating

This graph shows the current efficiency of your home, taking into account both energy efficiency and fuel costs. The higher this rating, the lower your fuel bills are likely to be.

Your current rating is **band B (83)**. The average rating for EPCs in Scotland is **band D (61)**.

The potential rating shows the effect of undertaking all of the improvement measures listed within your recommendations report.

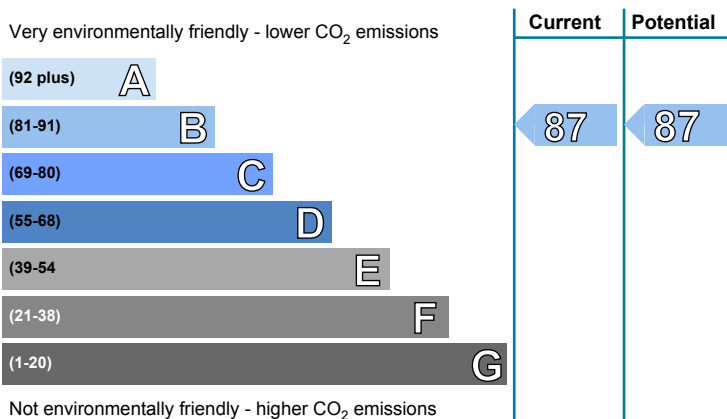
Environmental Impact (CO₂) Rating

This graph shows the effect of your home on the environment in terms of carbon dioxide (CO₂) emissions. The higher the rating, the less impact it has on the environment.
