FLAT 0/3
32 RANNOCH STREET
GLASGOW
G44 4DG

Home Report

FLAT 0/3 , 32 RANNOCH STREET, GLASGOW, G44 4DG

Dwelling type:	Ground-floor flat	Reference number:	2119-7122-3009-0330-1226
Date of assessment:	20 December 2021	Type of assessment:	RdSAP, existing dwelling
Date of certificate:	21 December 2021	Approved Organisation:	Elmhurst
Total floor area:	43 m ²	Main heating and fuel:	Electric storage heaters
Primary Energy Indicator:	608 kWh/m ² /year

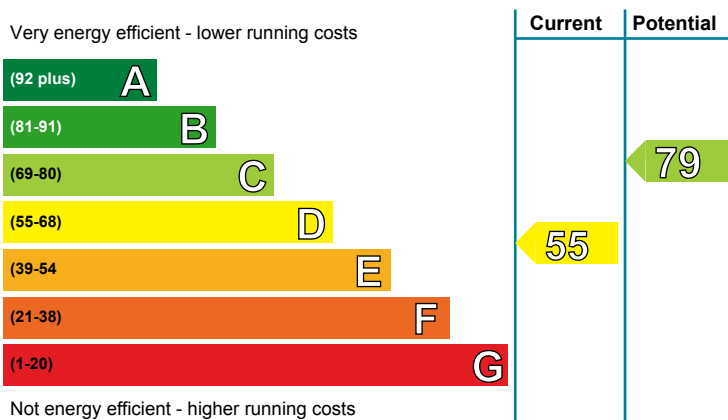
Energy Efficiency Rating

This graph shows the current efficiency of your home, taking into account both energy efficiency and fuel costs. The higher this rating, the lower your fuel bills are likely to be.

Your current rating is **band D (55)**. The average rating for EPCs in Scotland is **band D (61)**.

The potential rating shows the effect of undertaking all of the improvement measures listed within your recommendations report.

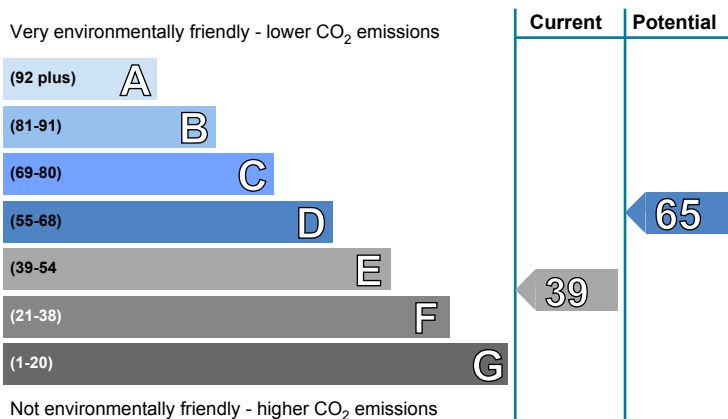
Environmental Impact (CO₂) Rating

This graph shows the effect of your home on the environment in terms of carbon dioxide (CO₂) emissions. The higher the rating, the less impact it has on the environment.

Your current rating is **band E (39)**. The average rating for EPCs in Scotland is **band D (59)**.

The potential rating shows the effect of undertaking all of the improvement measures listed within your recommendations report.
