# HOME REPORT

FLAT 2/1  
66 SINCLAIR STREET  
HELENSBURGH  
G84 8TP

# Energy Performance Certificate (EPC)

FLAT 2/1 , 66 SINCLAIR STREET, HELENSBURGH, G84 8TP

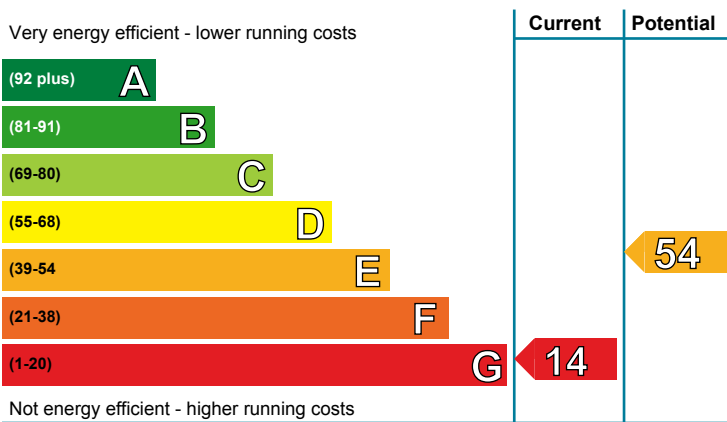
## Energy Efficiency Rating

This graph shows the current efficiency of your home, taking into account both energy efficiency and fuel costs. The higher this rating, the lower your fuel bills are likely to be.

Your current rating is **band G (14)**. The average rating for EPCs in Scotland is **band D (61)**.

The potential rating shows the effect of undertaking all of the improvement measures listed within your recommendations report.

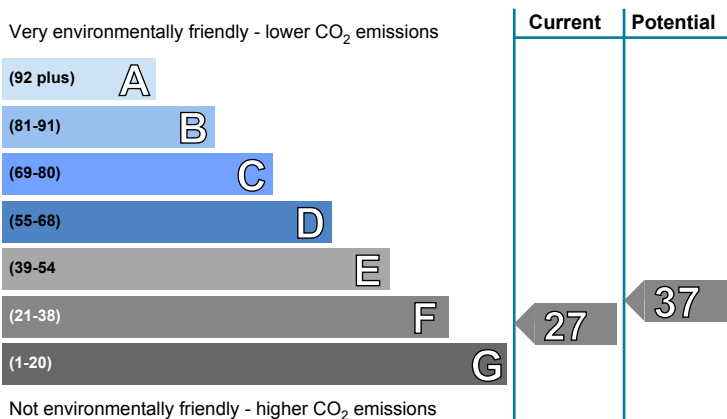
## Environmental Impact (CO<sub>2</sub>) Rating

This graph shows the effect of your home on the environment in terms of carbon dioxide (CO<sub>2</sub>) emissions. The higher the rating, the less impact it has on the environment.

Your current rating is **band F (27)**. The average rating for EPCs in Scotland is **band D (59)**.

The potential rating shows the effect of undertaking all of the improvement measures listed within your recommendations report.
