70 LOCKSLEY AVENUE  
GLASGOW  
G13 3XQ

# Home Report

# Energy Performance Certificate

70 LOCKSLEY AVENUE, GLASGOW, G13 3XQ

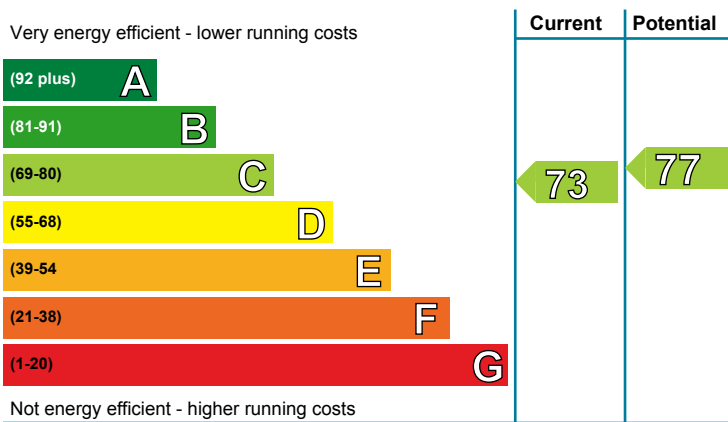
## Energy Efficiency Rating

This graph shows the current efficiency of your home, taking into account both energy efficiency and fuel costs. The higher this rating, the lower your fuel bills are likely to be.

Your current rating is **band C (73)**. The average rating for EPCs in Scotland is **band D (61)**.

The potential rating shows the effect of undertaking all of the improvement measures listed within your recommendations report.

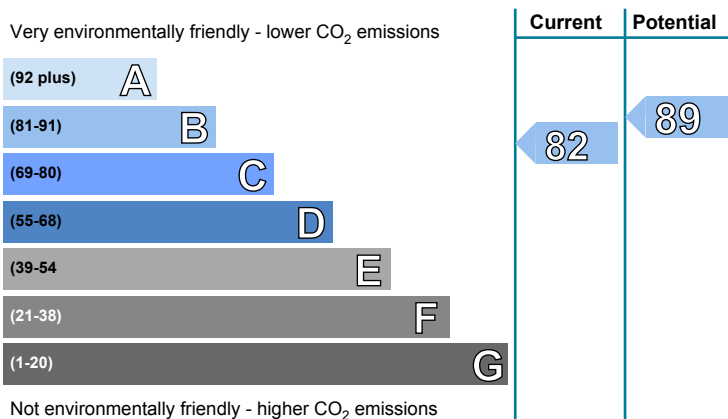
## Environmental Impact (CO<sub>2</sub>) Rating

This graph shows the effect of your home on the environment in terms of carbon dioxide (CO<sub>2</sub>) emissions. The higher the rating, the less impact it has on the environment.

Your current rating is **band B (82)**. The average rating for EPCs in Scotland is **band D (59)**.

The potential rating shows the effect of undertaking all of the improvement measures listed within your recommendations report.
