FLAT 3
18 MAVISBANK GARDENS
GLASGOW
G51 1HG

Home Report

FLAT 3 , 18 MAVISBANK GARDENS, GLASGOW, G51 1HG

Dwelling type: Mid-floor flat
Date of assessment: 26 May 2021
Date of certificate: 27 May 2021
Total floor area: 87 m²
Primary Energy Indicator: 231 kWh/m²/year

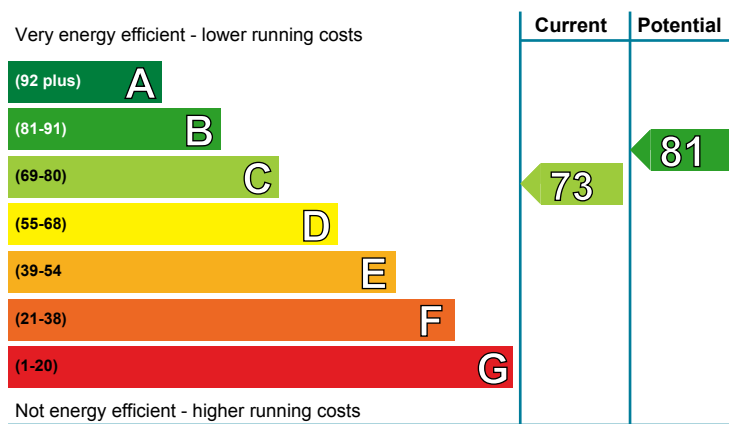
Energy Efficiency Rating

This graph shows the current efficiency of your home, taking into account both energy efficiency and fuel costs. The higher this rating, the lower your fuel bills are likely to be.

Your current rating is **band C (73)**. The average rating for EPCs in Scotland is **band D (61)**.

The potential rating shows the effect of undertaking all of the improvement measures listed within your recommendations report.

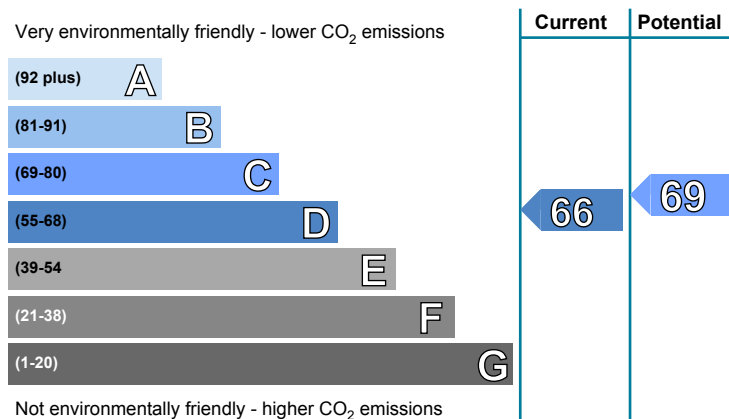
Environmental Impact (CO₂) Rating

This graph shows the effect of your home on the environment in terms of carbon dioxide (CO₂) emissions. The higher the rating, the less impact it has on the environment.

Your current rating is **band D (66)**. The average rating for EPCs in Scotland is **band D (59)**.

The potential rating shows the effect of undertaking all of the improvement measures listed within your recommendations report.
