# Home Report

# Single Survey

<b>Property address</b>	3/1 8 Allison Street Glasgow G42 8NN
<b>Customer</b>	Mr T. Lovat
<b>Customer address</b>	3/1 8 Allison Street Glasgow G42 8NN
<b>Prepared by</b>	Shepherd Chartered Surveyors
<b>Date of inspection</b>	11/04/2024

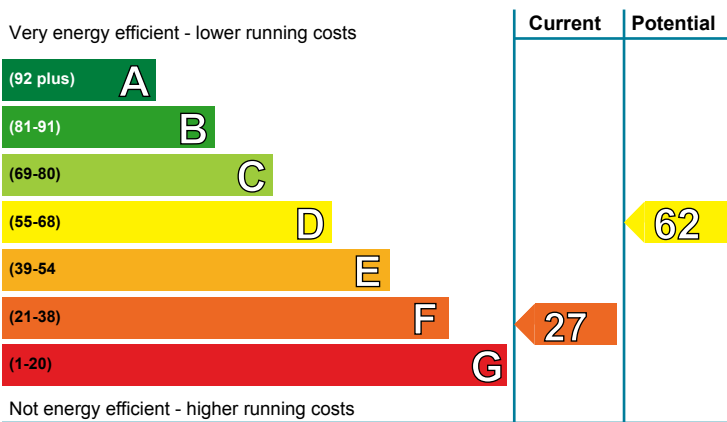
## Energy Efficiency Rating

This graph shows the current efficiency of your home, taking into account both energy efficiency and fuel costs. The higher this rating, the lower your fuel bills are likely to be.

Your current rating is **band F (27)**. The average rating for EPCs in Scotland is **band D (61)**.

The potential rating shows the effect of undertaking all of the improvement measures listed within your recommendations report.

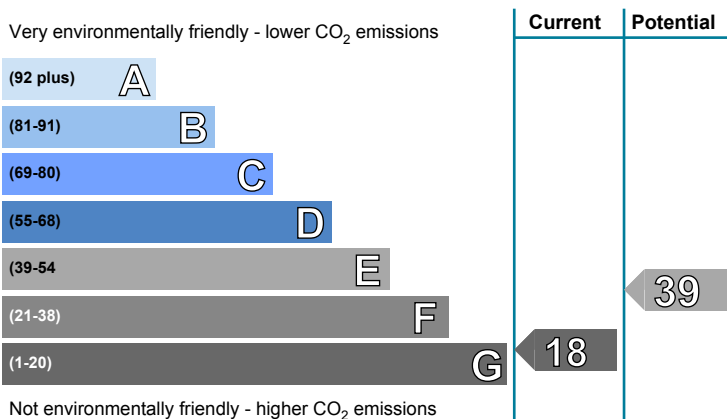
## Environmental Impact (CO<sub>2</sub>) Rating

This graph shows the effect of your home on the environment in terms of carbon dioxide (CO<sub>2</sub>) emissions. The higher the rating, the less impact it has on the environment.
