FLAT 4/2
11 FINLAY DRIVE
GLASGOW
G31 2BD

Home Report

Scottish Single Survey

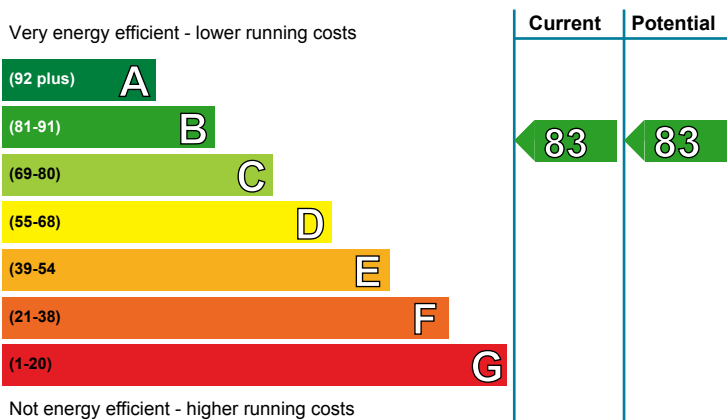
Energy Efficiency Rating

This graph shows the current efficiency of your home, taking into account both energy efficiency and fuel costs. The higher this rating, the lower your fuel bills are likely to be.

Your current rating is **band B (83)**. The average rating for EPCs in Scotland is **band D (61)**.

The potential rating shows the effect of undertaking all of the improvement measures listed within your recommendations report.

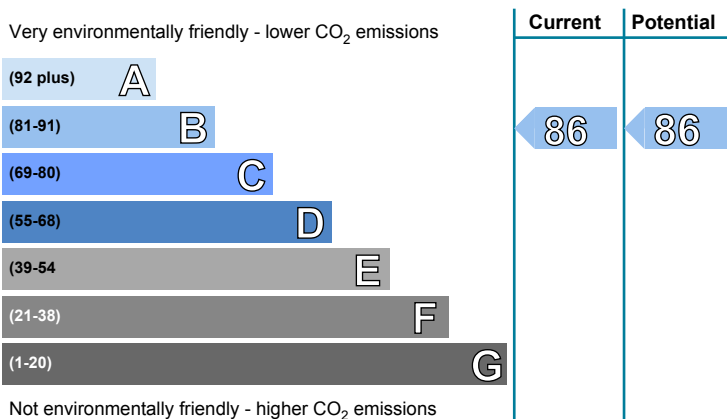
Environmental Impact (CO₂) Rating

This graph shows the effect of your home on the environment in terms of carbon dioxide (CO₂) emissions. The higher the rating, the less impact it has on the environment.

Your current rating is **band B (86)**. The average rating for EPCs in Scotland is **band D (59)**.

The potential rating shows the effect of undertaking all of the improvement measures listed within your recommendations report.
