Home Report

Scottish Single Survey

Property address	2/2 1159 Dumbarton Road Glasgow G14 9TR
Customer	Mrs J. Feeney
Customer address	2/2 1159 Dumbarton Road Glasgow G14 9TR
Prepared by	Shepherd Chartered Surveyors
Date of inspection	19/03/2024

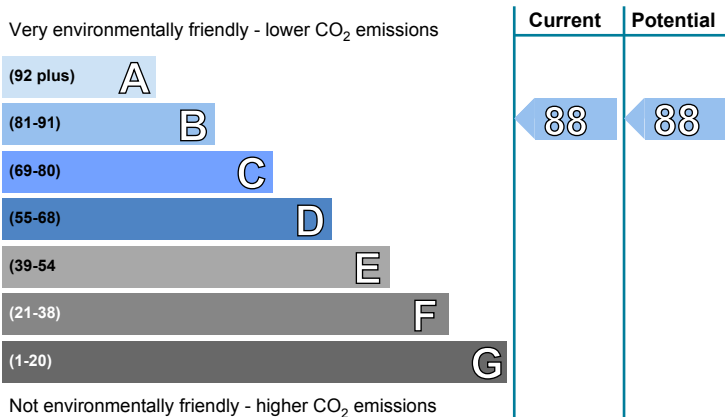
Environmental Impact (CO₂) Rating

This graph shows the effect of your home on the environment in terms of carbon dioxide (CO₂) emissions. The higher the rating, the less impact it has on the environment.
