113 RIDDELL STREET
CLYDEBANK
G81 2DH

Home Report

113 RIDDELL STREET, CLYDEBANK, G81 2DH

Dwelling type: Semi-detached house
Date of assessment: 02 July 2021
Date of certificate: 05 July 2021
Total floor area: 91 m²
Primary Energy Indicator: 232 kWh/m²/year

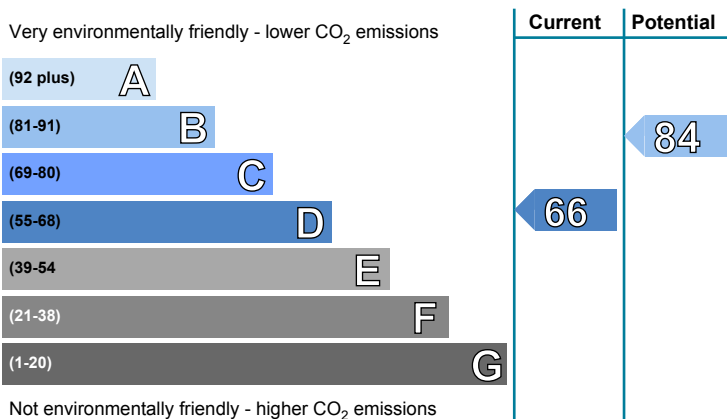
Environmental Impact (CO₂) Rating

This graph shows the effect of your home on the environment in terms of carbon dioxide (CO₂) emissions. The higher the rating, the less impact it has on the environment.

Your current rating is **band D (66)**. The average rating for EPCs in Scotland is **band D (59)**.

The potential rating shows the effect of undertaking all of the improvement measures listed within your recommendations report.
