Home Report

Scottish Single Survey

Property address	51 Melville Gardens Bishopbriggs Glasgow G64 3DD
-------------------------	---

Prepared by	Shepherd Chartered Surveyors
--------------------	------------------------------

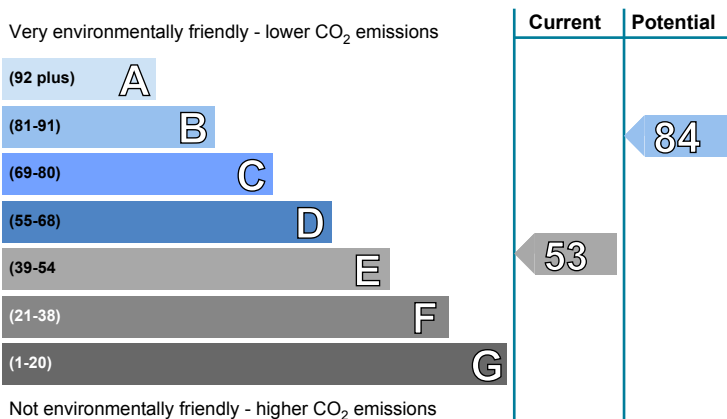
Environmental Impact (CO₂) Rating

This graph shows the effect of your home on the environment in terms of carbon dioxide (CO₂) emissions. The higher the rating, the less impact it has on the environment.
