FLAT 2/2  
14 WHITEFIELD ROAD  
GLASGOW  
G51 2YD

# Home Report

# Scottish Single Survey

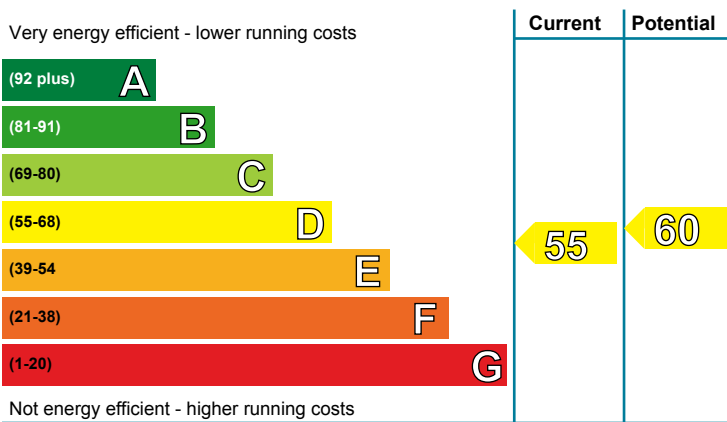
## Energy Efficiency Rating

This graph shows the current efficiency of your home, taking into account both energy efficiency and fuel costs. The higher this rating, the lower your fuel bills are likely to be.

Your current rating is **band D (55)**. The average rating for EPCs in Scotland is **band D (61)**.

The potential rating shows the effect of undertaking all of the improvement measures listed within your recommendations report.

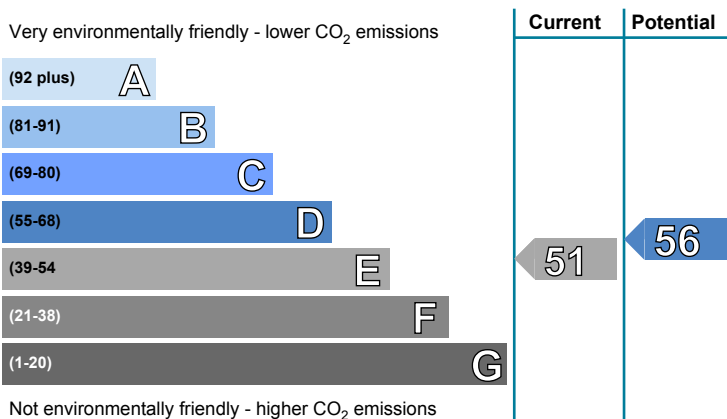
## Environmental Impact (CO<sub>2</sub>) Rating

This graph shows the effect of your home on the environment in terms of carbon dioxide (CO<sub>2</sub>) emissions. The higher the rating, the less impact it has on the environment.

Your current rating is **band E (51)**. The average rating for EPCs in Scotland is **band D (59)**.

The potential rating shows the effect of undertaking all of the improvement measures listed within your recommendations report.
