# HOME REPORT

51 MAIN STREET  
GUARDBRIDGE  
ST ANDREWS  
KY16 0UH

# SINGLE SURVEY

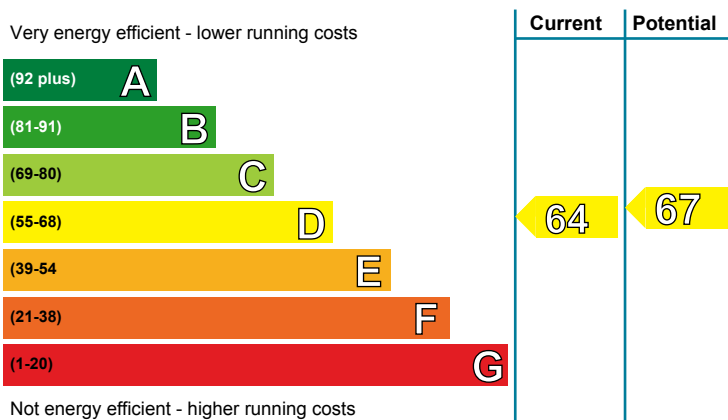
## Energy Efficiency Rating

This graph shows the current efficiency of your home, taking into account both energy efficiency and fuel costs. The higher this rating, the lower your fuel bills are likely to be.

Your current rating is **band D (64)**. The average rating for EPCs in Scotland is **band D (61)**.

The potential rating shows the effect of undertaking all of the improvement measures listed within your recommendations report.
