# HOME REPORT

71 MAIN STREET  
GUARDBRIDGE  
ST ANDREWS  
KY16 0UJ

71 MAIN STREET, GUARDBRIDGE, ST ANDREWS, KY16 0UJ

**Dwelling type:** Ground-floor flat  
**Date of assessment:** 13 May 2021  
**Date of certificate:** 17 May 2021  
**Total floor area:** 77 m<sup>2</sup>  
**Primary Energy Indicator:** 410 kWh/m<sup>2</sup>/year

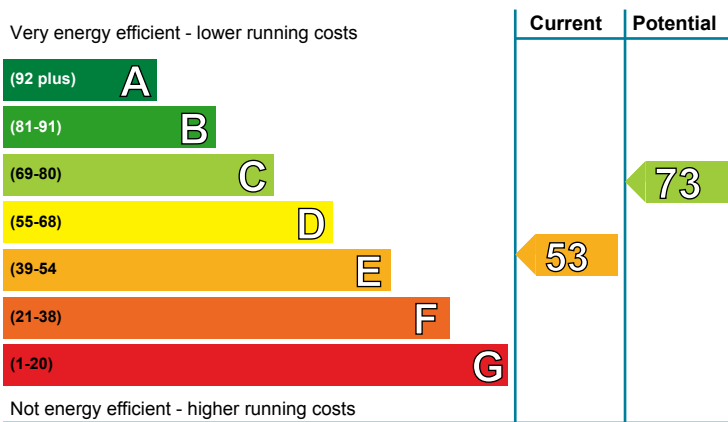
## Energy Efficiency Rating

This graph shows the current efficiency of your home, taking into account both energy efficiency and fuel costs. The higher this rating, the lower your fuel bills are likely to be.

Your current rating is **band E (53)**. The average rating for EPCs in Scotland is **band D (61)**.

The potential rating shows the effect of undertaking all of the improvement measures listed within your recommendations report.

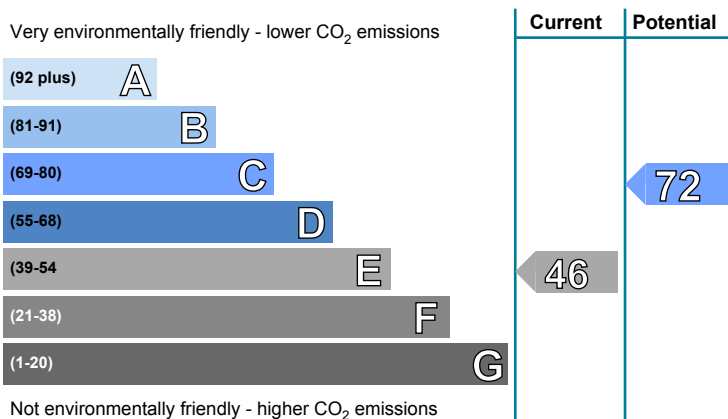
## Environmental Impact (CO<sub>2</sub>) Rating

This graph shows the effect of your home on the environment in terms of carbon dioxide (CO<sub>2</sub>) emissions. The higher the rating, the less impact it has on the environment.

Your current rating is **band E (46)**. The average rating for EPCs in Scotland is **band D (59)**.

The potential rating shows the effect of undertaking all of the improvement measures listed within your recommendations report.
