FLAT 3/2
14 KENNOWAY DRIVE
GLASGOW
G11 7UB

Home Report

FLAT 3/2, 14 KENNOWAY DRIVE, GLASGOW, G11 7UB

Scottish Single Survey

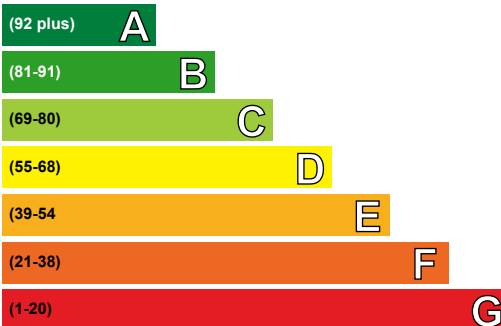
Energy Efficiency Rating

Very energy efficient - lower running costs

Not energy efficient - higher running costs

Current	Potential
48	62

The potential rating shows the effect of undertaking all of the improvement measures listed within your recommendations report.

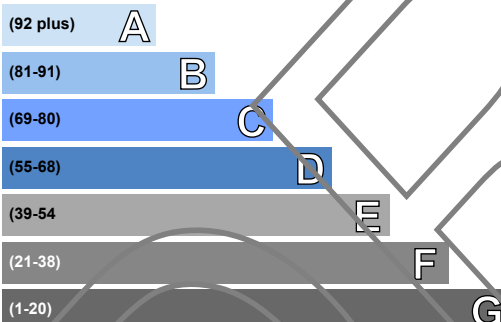
Very environmentally friendly - lower CO₂ emissions

Not environmentally friendly - higher CO₂ emissions

Current	Potential
46	62

The potential rating shows the effect of undertaking all of the improvement measures listed within your recommendations report.

The average Scottish household produces about 6 tonnes of carbon dioxide every year. Based on this assessment, heating and lighting this home currently produces approximately 3.9 tonnes of carbon dioxide every year. Adopting recommendations in this report can reduce emissions and protect the environment. If you were to install all of these recommendations this could reduce emissions by 1.3 tonnes per year. You could reduce emissions even more by switching to renewable energy sources.

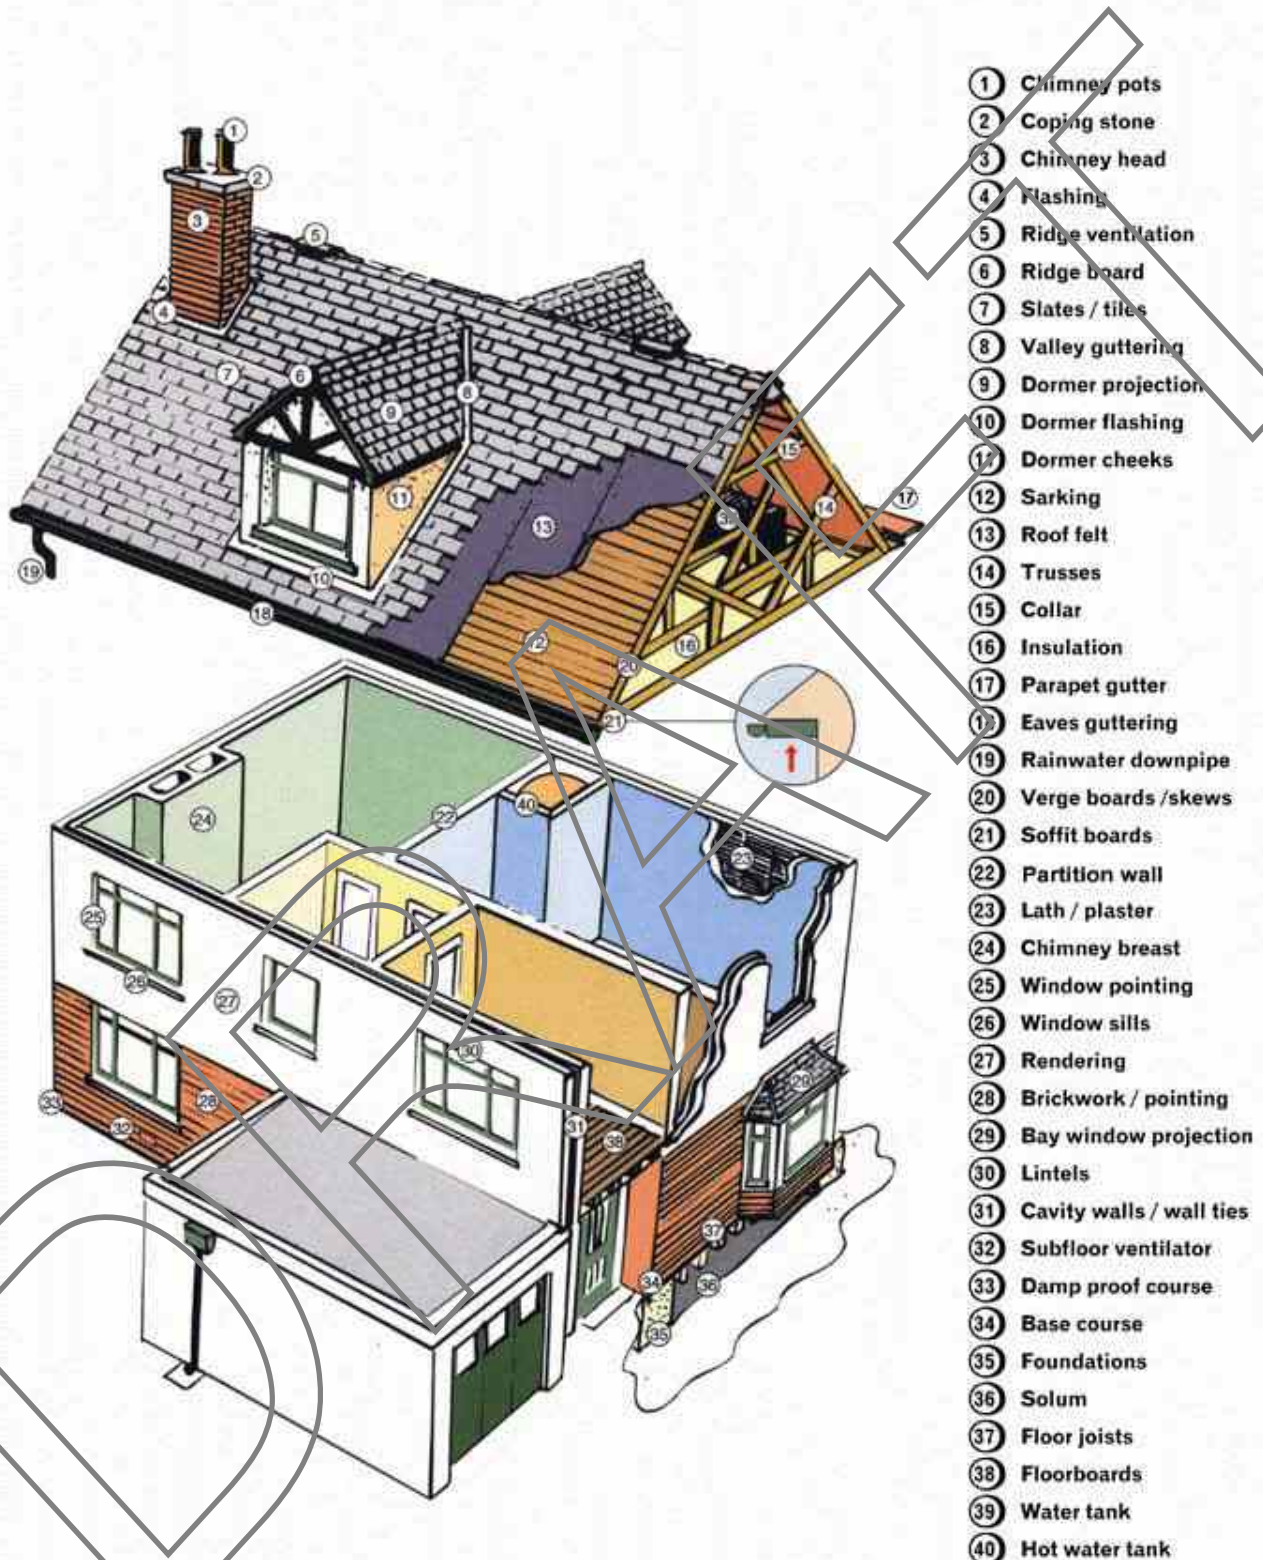
Sectional Diagram showing elements of a typical house

Reference may be made in this report to some or all of the above component parts of the property. This diagram may assist you in locating and understanding these items.
