25 HIGH BURNSIDE AVENUE
LANGLOAN
COATBRIDGE
ML5 1HZ

Home Report

Scottish Single Survey

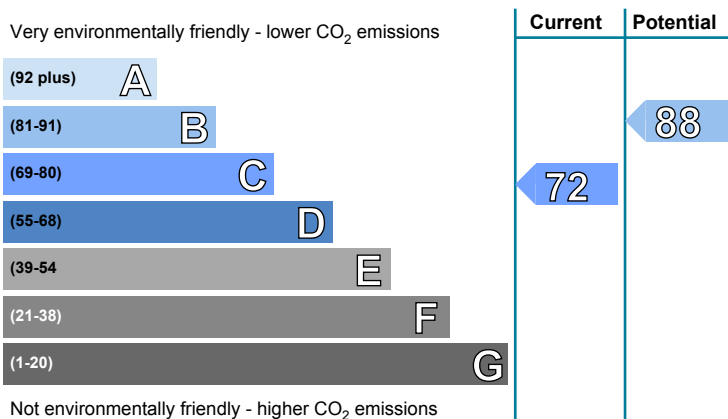
Environmental Impact (CO₂) Rating

This graph shows the effect of your home on the environment in terms of carbon dioxide (CO₂) emissions. The higher the rating, the less impact it has on the environment.

Your current rating is **band C (72)**. The average rating for EPCs in Scotland is **band D (59)**.

The potential rating shows the effect of undertaking all of the improvement measures listed within your recommendations report.
