Home Report

Single Survey

Property address	3/1 22 Albert Road Glasgow G42 8DN
Customer	Mr Robert Furman
Customer address	3/1 22 Albert Road Glasgow G42 8DN
Prepared by	Shepherd Chartered Surveyors
Date of inspection	01/08/2023

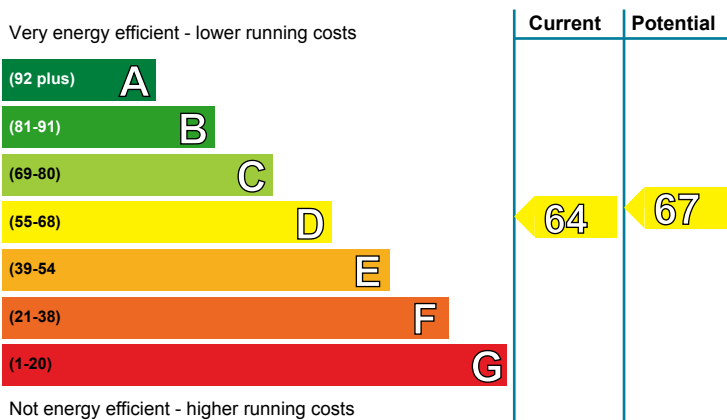
Energy Efficiency Rating

This graph shows the current efficiency of your home, taking into account both energy efficiency and fuel costs. The higher this rating, the lower your fuel bills are likely to be.

Your current rating is **band D (64)**. The average rating for EPCs in Scotland is **band D (61)**.

The potential rating shows the effect of undertaking all of the improvement measures listed within your recommendations report.

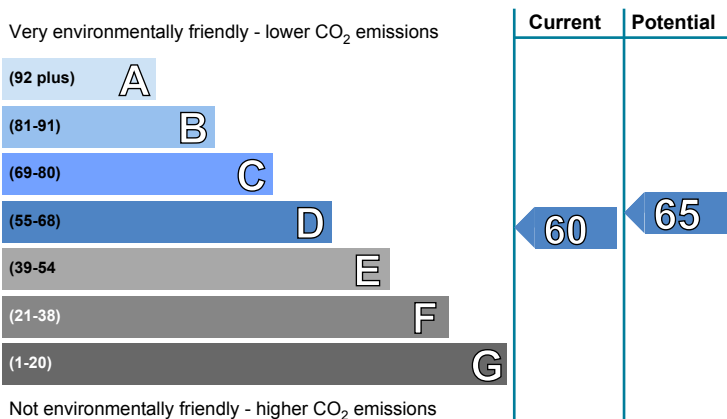
Environmental Impact (CO₂) Rating

This graph shows the effect of your home on the environment in terms of carbon dioxide (CO₂) emissions. The higher the rating, the less impact it has on the environment.
