FLAT 1/2
194 COPLAND ROAD
GLASGOW
G51 2UN

Home Report

FLAT 1/2 , 194 COPLAND ROAD, GLASGOW, G51 2UN

Scottish Single Survey

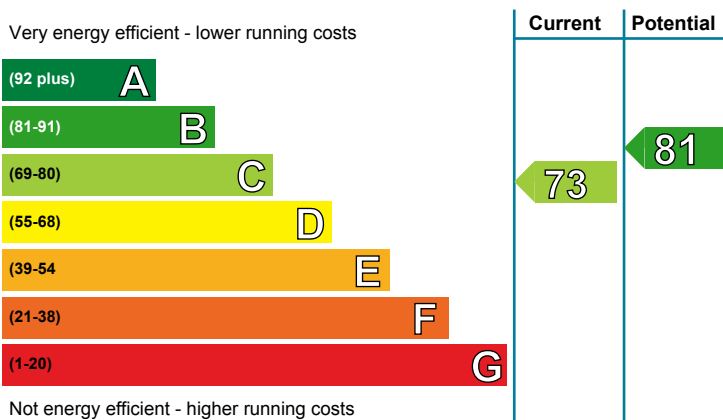
Energy Efficiency Rating

This graph shows the current efficiency of your home, taking into account both energy efficiency and fuel costs. The higher this rating, the lower your fuel bills are likely to be.

Your current rating is **band C (73)**. The average rating for EPCs in Scotland is **band D (61)**.

The potential rating shows the effect of undertaking all of the improvement measures listed within your recommendations report.

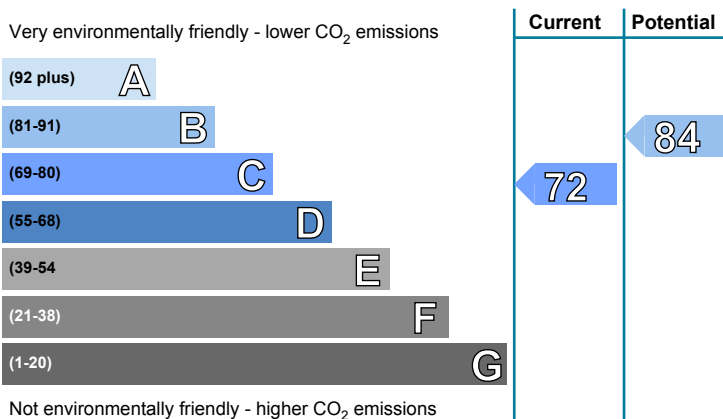
Environmental Impact (CO₂) Rating

This graph shows the effect of your home on the environment in terms of carbon dioxide (CO₂) emissions. The higher the rating, the less impact it has on the environment.

Your current rating is **band C (72)**. The average rating for EPCs in Scotland is **band D (59)**.

The potential rating shows the effect of undertaking all of the improvement measures listed within your recommendations report.
