FLAT 0/1  
93 HOPEHILL ROAD  
GLASGOW  
G20 7HH

# Home Report

# Energy Performance Certificate

# Scottish Single Survey

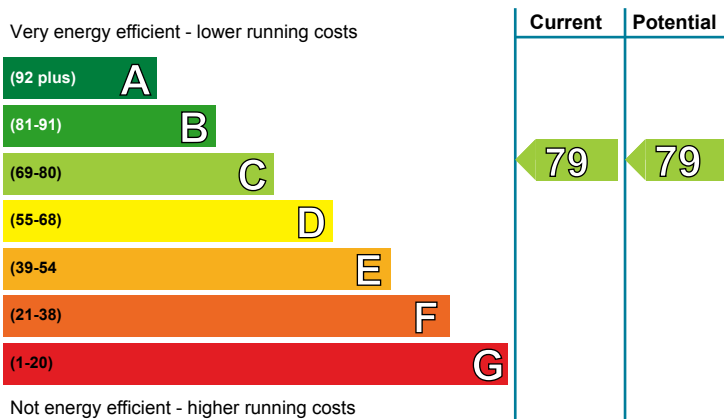
## Energy Efficiency Rating

This graph shows the current efficiency of your home, taking into account both energy efficiency and fuel costs. The higher this rating, the lower your fuel bills are likely to be.

Your current rating is **band C (79)**. The average rating for EPCs in Scotland is **band D (61)**.

The potential rating shows the effect of undertaking all of the improvement measures listed within your recommendations report.
