HOME REPORT

92 MONTFORD AVENUE
GLASGOW
G44 4NZ

Energy Performance Certificate (EPC)

92 MONTFORD AVENUE, GLASGOW, G44 4NZ

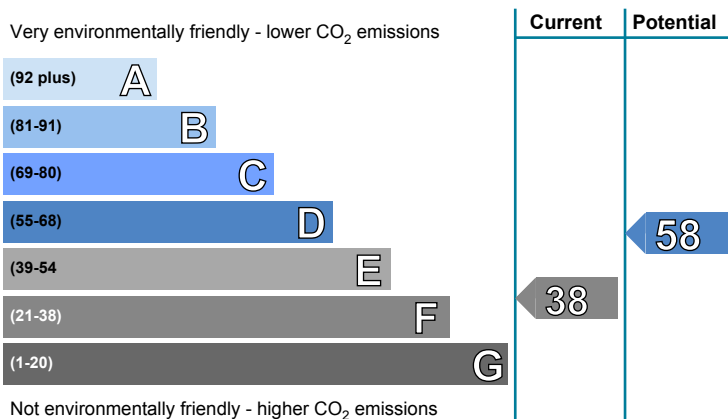
Environmental Impact (CO₂) Rating

This graph shows the effect of your home on the environment in terms of carbon dioxide (CO₂) emissions. The higher the rating, the less impact it has on the environment.

Your current rating is **band F (38)**. The average rating for EPCs in Scotland is **band D (59)**.

The potential rating shows the effect of undertaking all of the improvement measures listed within your recommendations report.
