HOME REPORT

FLAT 3/1
6 GARRIOCH DRIVE
GLASGOW
G20 8RP

Energy Performance Certificate (EPC)

Single Survey

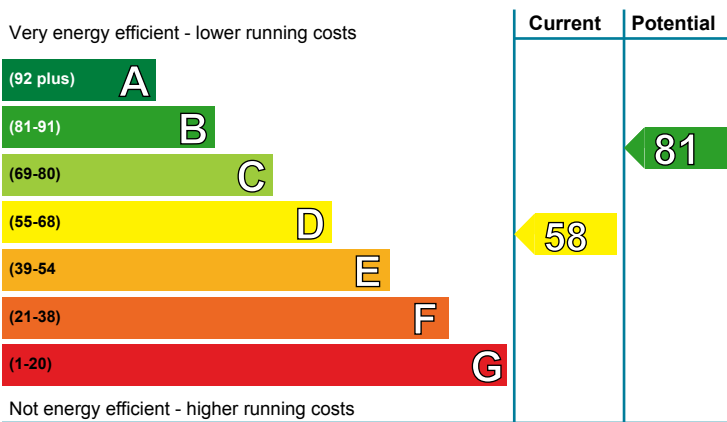
Energy Efficiency Rating

This graph shows the current efficiency of your home, taking into account both energy efficiency and fuel costs. The higher this rating, the lower your fuel bills are likely to be.

Your current rating is **band D (58)**. The average rating for EPCs in Scotland is **band D (61)**.

The potential rating shows the effect of undertaking all of the improvement measures listed within your recommendations report.

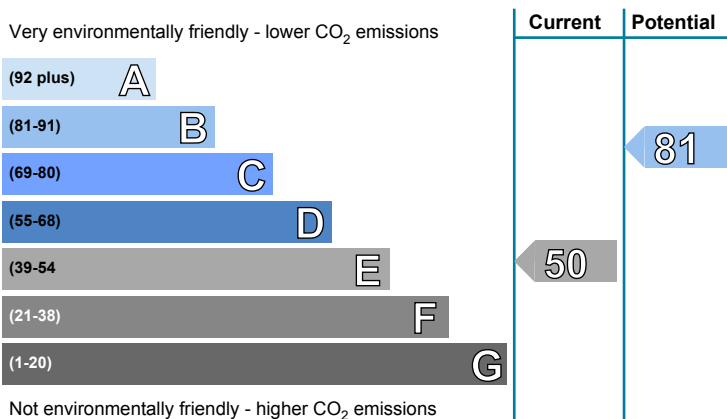
Environmental Impact (CO₂) Rating

This graph shows the effect of your home on the environment in terms of carbon dioxide (CO₂) emissions. The higher the rating, the less impact it has on the environment.

Your current rating is **band E (50)**. The average rating for EPCs in Scotland is **band D (59)**.

The potential rating shows the effect of undertaking all of the improvement measures listed within your recommendations report.
