# Home Report

# Scottish Single Survey

<b>Property address</b>	3/2 26 Kilmuir Road Thornliebank Glasgow G46 8BQ
-------------------------	--

<b>Prepared by</b>	Shepherd Chartered Surveyors
--------------------	------------------------------

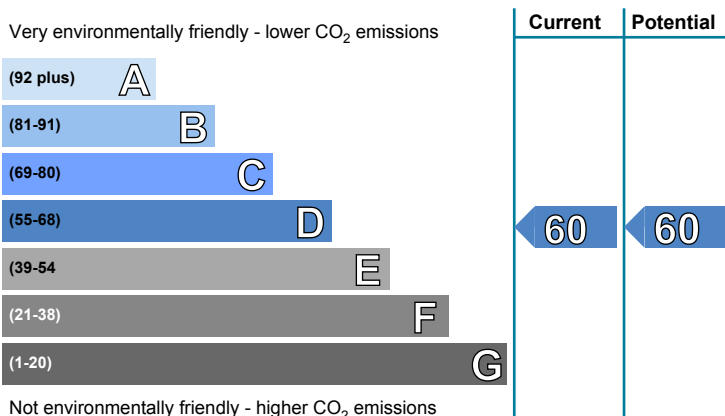
## Environmental Impact (CO<sub>2</sub>) Rating

This graph shows the effect of your home on the environment in terms of carbon dioxide (CO<sub>2</sub>) emissions. The higher the rating, the less impact it has on the environment.
