FLAT 1/1  
10 GARRIOCH CRESCENT  
GLASGOW  
G20 8RR

# Home Report

# Energy Performance Certificate

# Single Survey

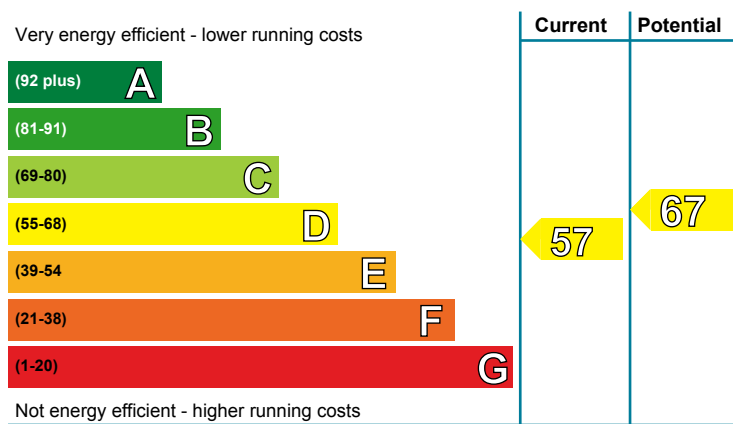
## Energy Efficiency Rating

This graph shows the current efficiency of your home, taking into account both energy efficiency and fuel costs. The higher this rating, the lower your fuel bills are likely to be.

Your current rating is **band D (57)**. The average rating for EPCs in Scotland is **band D (61)**.

The potential rating shows the effect of undertaking all of the improvement measures listed within your recommendations report.

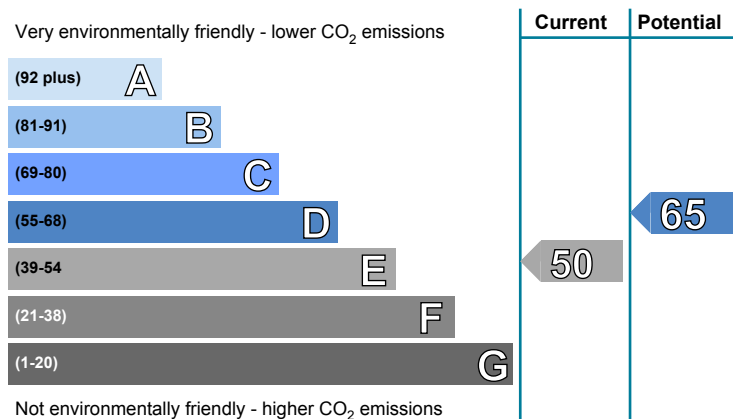
## Environmental Impact (CO<sub>2</sub>) Rating

This graph shows the effect of your home on the environment in terms of carbon dioxide (CO<sub>2</sub>) emissions. The higher the rating, the less impact it has on the environment.

Your current rating is **band E (50)**. The average rating for EPCs in Scotland is **band D (59)**.

The potential rating shows the effect of undertaking all of the improvement measures listed within your recommendations report.
