208 KIRKTON AVENUE  
GLASGOW  
G13 3AE

# Home Report

# Energy Performance Certificate

# Scottish Single Survey

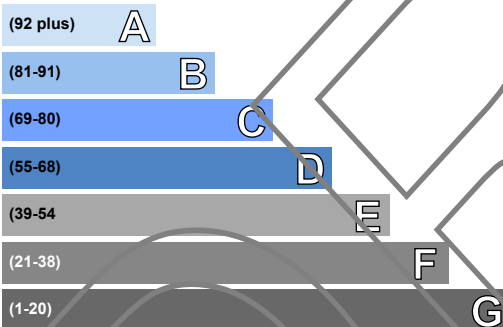
Very environmentally friendly - lower CO<sub>2</sub> emissions

Not environmentally friendly - higher CO<sub>2</sub> emissions

| Current | Potential |
