YOUR ONESURVEY
HOME REPORT

59 Fairfield Park
Ayr
KA7 2AU

SINGLE SURVEY

Single Survey

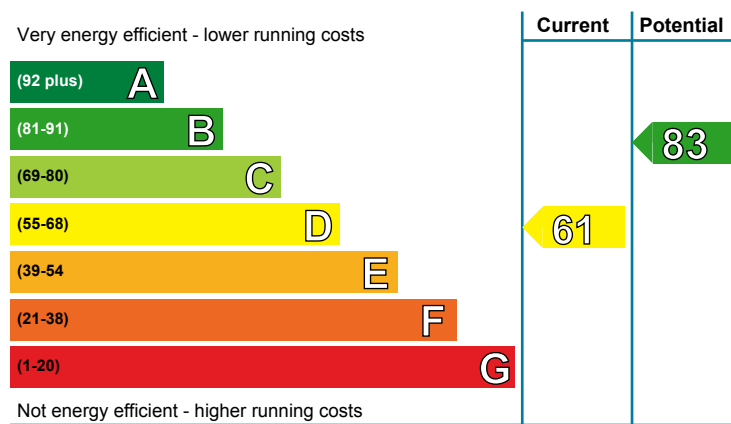
Energy Efficiency Rating

This graph shows the current efficiency of your home, taking into account both energy efficiency and fuel costs. The higher this rating, the lower your fuel bills are likely to be.

Your current rating is **band D (61)**. The average rating for EPCs in Scotland is **band D (61)**.

The potential rating shows the effect of undertaking all of the improvement measures listed within your recommendations report.

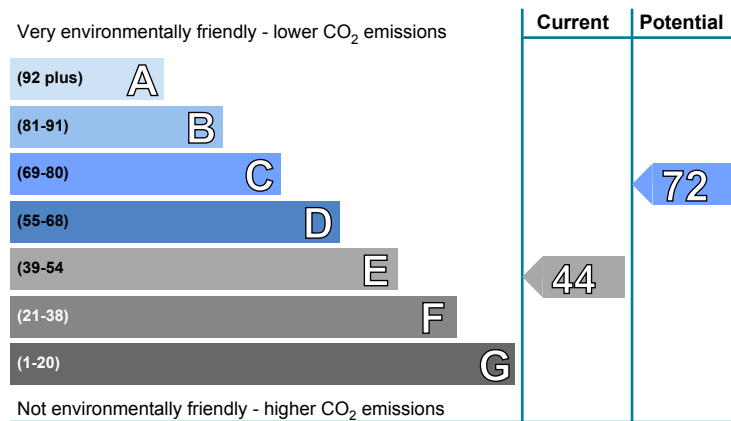
Environmental Impact (CO₂) Rating

This graph shows the effect of your home on the environment in terms of carbon dioxide (CO₂) emissions. The higher the rating, the less impact it has on the environment.
