YOUR ONESURVEY
HOME REPORT

9 Somerville Way
Lawthorn, Irvine
KA11 2EQ

SINGLE SURVEY

Single Survey

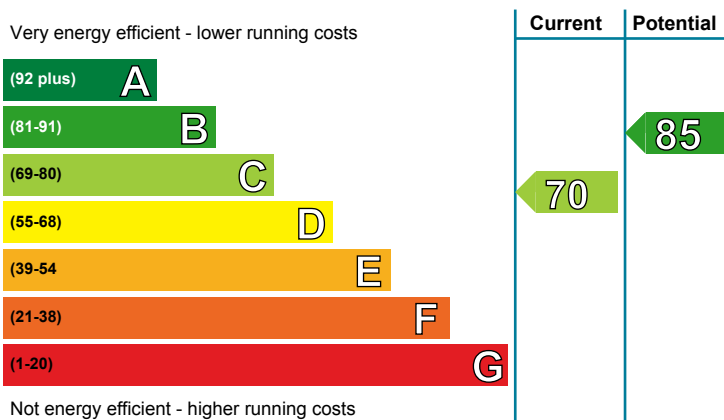
Energy Efficiency Rating

This graph shows the current efficiency of your home, taking into account both energy efficiency and fuel costs. The higher this rating, the lower your fuel bills are likely to be.

Your current rating is **band C (70)**. The average rating for EPCs in Scotland is **band D (61)**.

The potential rating shows the effect of undertaking all of the improvement measures listed within your recommendations report.

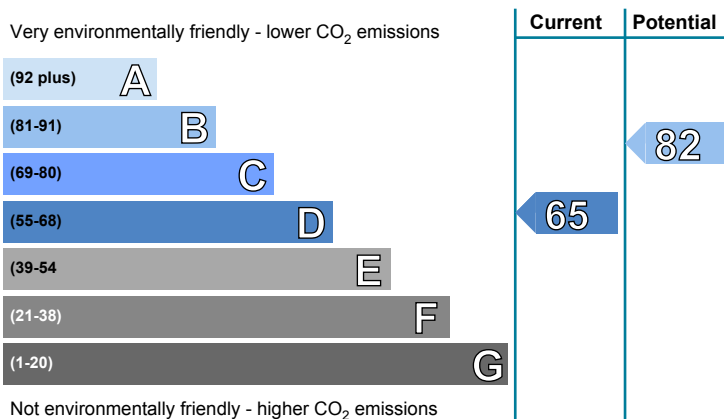
Environmental Impact (CO₂) Rating

This graph shows the effect of your home on the environment in terms of carbon dioxide (CO₂) emissions. The higher the rating, the less impact it has on the environment.
