Energy Performance Certificate

3 GALVELMORE STREET, CRIEFF, PH7 4DN

Dwelling type: Top-floor maisonette
Date of assessment: 18 December 2023
Date of certificate: 20 December 2023
Total floor area: 274 m²
Primary Energy Indicator: 276 kWh/m²/year

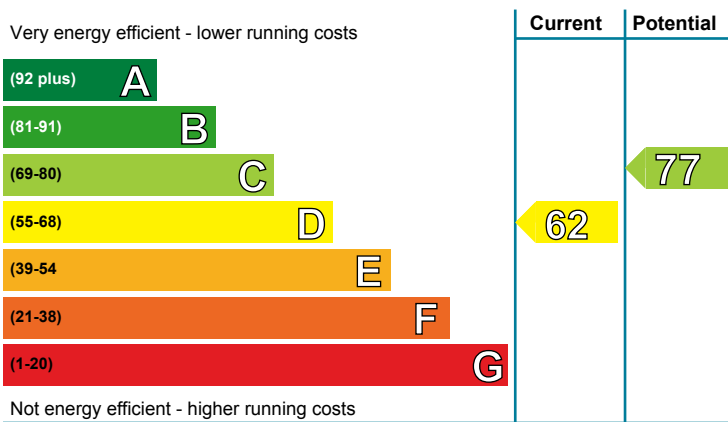
Energy Efficiency Rating

This graph shows the current efficiency of your home, taking into account both energy efficiency and fuel costs. The higher this rating, the lower your fuel bills are likely to be.

Your current rating is **band D (62)**. The average rating for EPCs in Scotland is **band D (61)**.

The potential rating shows the effect of undertaking all of the improvement measures listed within your recommendations report.
