Single Survey

4 St Clair Court
Castletown
KW14 8UF

survey report on :

Customer	Hercules Robinson
Customer Address	7 Vyner Place Ullapool IV26 2XR
Date of Inspection	9 th April 2024
Prepared by	Keith Bowman BSc MRICS Registered Valuer

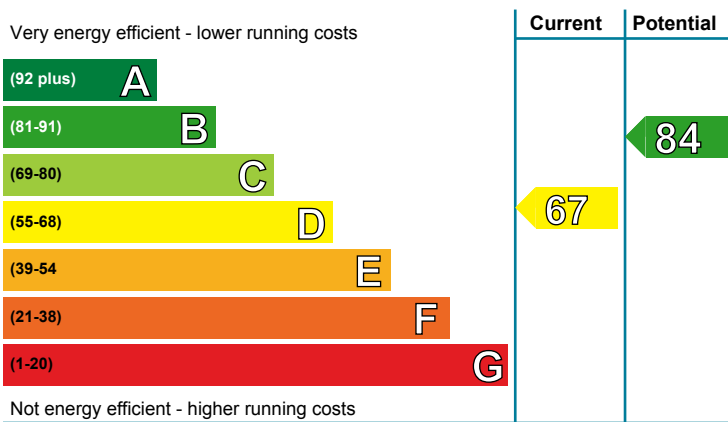
Energy Efficiency Rating

This graph shows the current efficiency of your home, taking into account both energy efficiency and fuel costs. The higher this rating, the lower your fuel bills are likely to be.

Your current rating is **band D (67)**. The average rating for EPCs in Scotland is **band D (61)**.

The potential rating shows the effect of undertaking all of the improvement measures listed within your recommendations report.
