HOME REPORT

BOORAGTOON
55 DURNESS STREET
THURSO
KW14 8BQ

SINGLE SURVEY

Single Survey

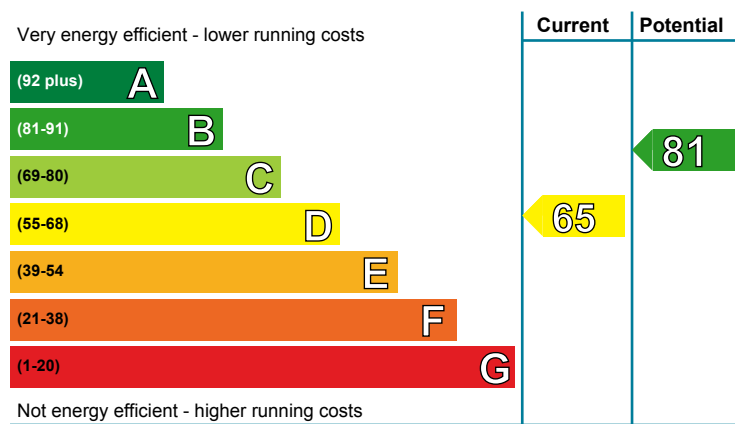
Energy Efficiency Rating

This graph shows the current efficiency of your home, taking into account both energy efficiency and fuel costs. The higher this rating, the lower your fuel bills are likely to be.

Your current rating is **band D (65)**. The average rating for EPCs in Scotland is **band D (61)**.

The potential rating shows the effect of undertaking all of the improvement measures listed within your recommendations report.

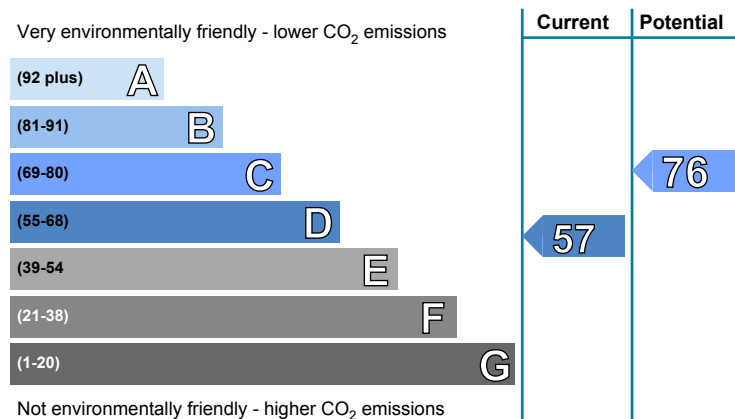
Environmental Impact (CO₂) Rating

This graph shows the effect of your home on the environment in terms of carbon dioxide (CO₂) emissions. The higher the rating, the less impact it has on the environment.

Your current rating is **band D (57)**. The average rating for EPCs in Scotland is **band D (59)**.

The potential rating shows the effect of undertaking all of the improvement measures listed within your recommendations report.
