HOME REPORT

17 ROYAL TERRACE
SPRINGPARK
THURSO
KW14 8NW

Energy Performance Certificate (EPC)

Single Survey

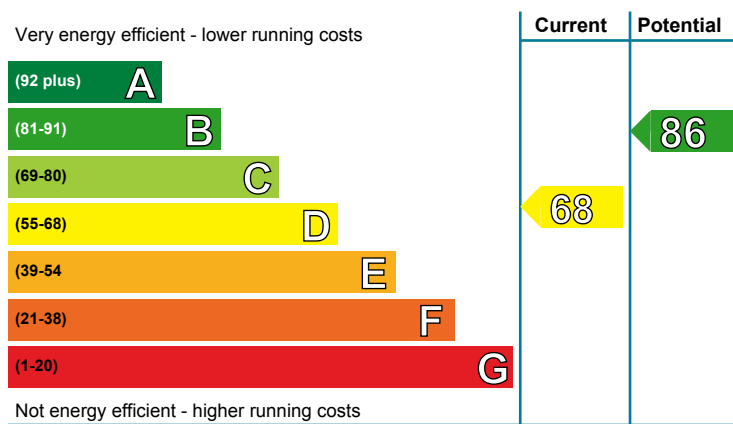
Energy Efficiency Rating

This graph shows the current efficiency of your home, taking into account both energy efficiency and fuel costs. The higher this rating, the lower your fuel bills are likely to be.

Your current rating is **band D (68)**. The average rating for EPCs in Scotland is **band D (61)**.

The potential rating shows the effect of undertaking all of the improvement measures listed within your recommendations report.

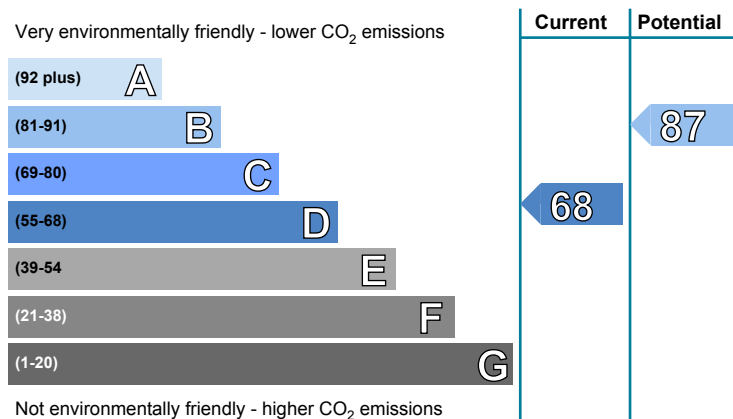
Environmental Impact (CO₂) Rating

This graph shows the effect of your home on the environment in terms of carbon dioxide (CO₂) emissions. The higher the rating, the less impact it has on the environment.

Your current rating is **band D (68)**. The average rating for EPCs in Scotland is **band D (59)**.

The potential rating shows the effect of undertaking all of the improvement measures listed within your recommendations report.
