HOME REPORT

37D ST ANDREWS STREET
DUNDEE
DD1 2EU

Energy Performance Certificate (EPC)

Single Survey

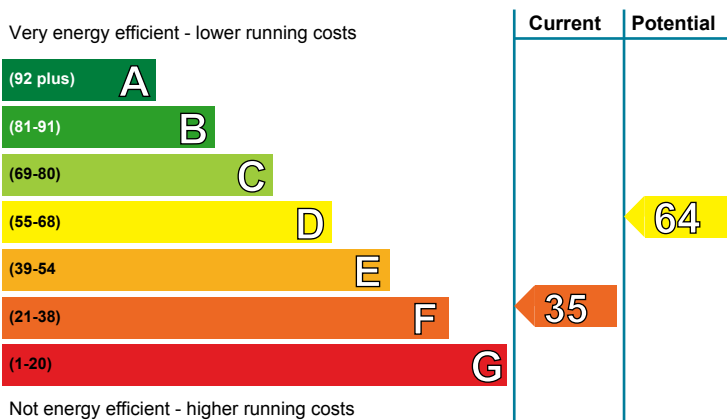
Energy Efficiency Rating

This graph shows the current efficiency of your home, taking into account both energy efficiency and fuel costs. The higher this rating, the lower your fuel bills are likely to be.

Your current rating is **band F (35)**. The average rating for EPCs in Scotland is **band D (61)**.

The potential rating shows the effect of undertaking all of the improvement measures listed within your recommendations report.
