HOME REPORT

66 MAYFIELD GROVE
DUNDEE
DD4 7GZ

Energy Performance Certificate (EPC)

Single Survey

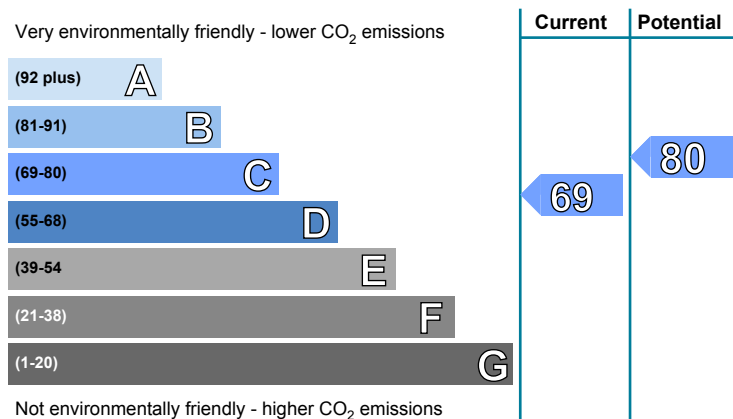
Environmental Impact (CO₂) Rating

This graph shows the effect of your home on the environment in terms of carbon dioxide (CO₂) emissions. The higher the rating, the less impact it has on the environment.

Your current rating is **band C (69)**. The average rating for EPCs in Scotland is **band D (59)**.

The potential rating shows the effect of undertaking all of the improvement measures listed within your recommendations report.
