HOME REPORT

2/1
20 ST ANDREWS STREET
DUNDEE
DD1 2EX

DM HALL
CHARTERED SURVEYORS

Energy Performance Certificate (EPC)

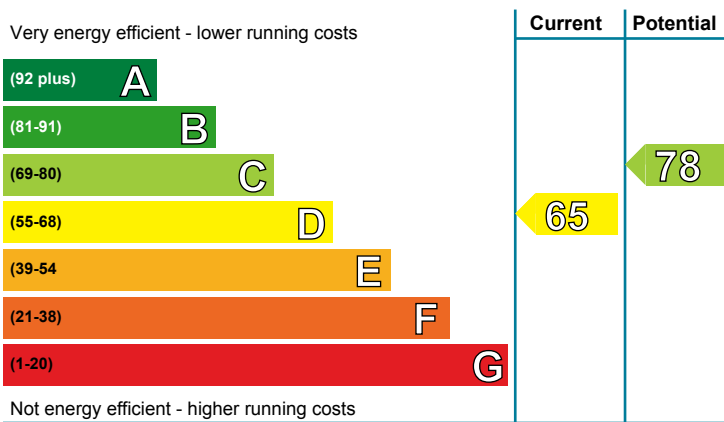
Energy Efficiency Rating

This graph shows the current efficiency of your home, taking into account both energy efficiency and fuel costs. The higher this rating, the lower your fuel bills are likely to be.

Your current rating is **band D (65)**. The average rating for EPCs in Scotland is **band D (61)**.

The potential rating shows the effect of undertaking all of the improvement measures listed within your recommendations report.

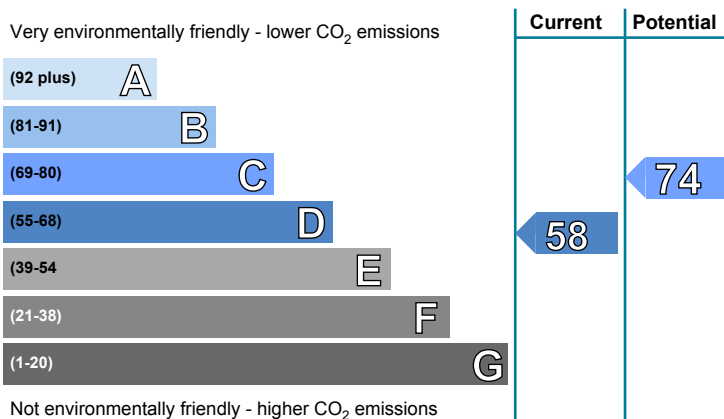
Environmental Impact (CO₂) Rating

This graph shows the effect of your home on the environment in terms of carbon dioxide (CO₂) emissions. The higher the rating, the less impact it has on the environment.

Your current rating is **band D (58)**. The average rating for EPCs in Scotland is **band D (59)**.

The potential rating shows the effect of undertaking all of the improvement measures listed within your recommendations report.
