# Single Survey

## 2. Condition

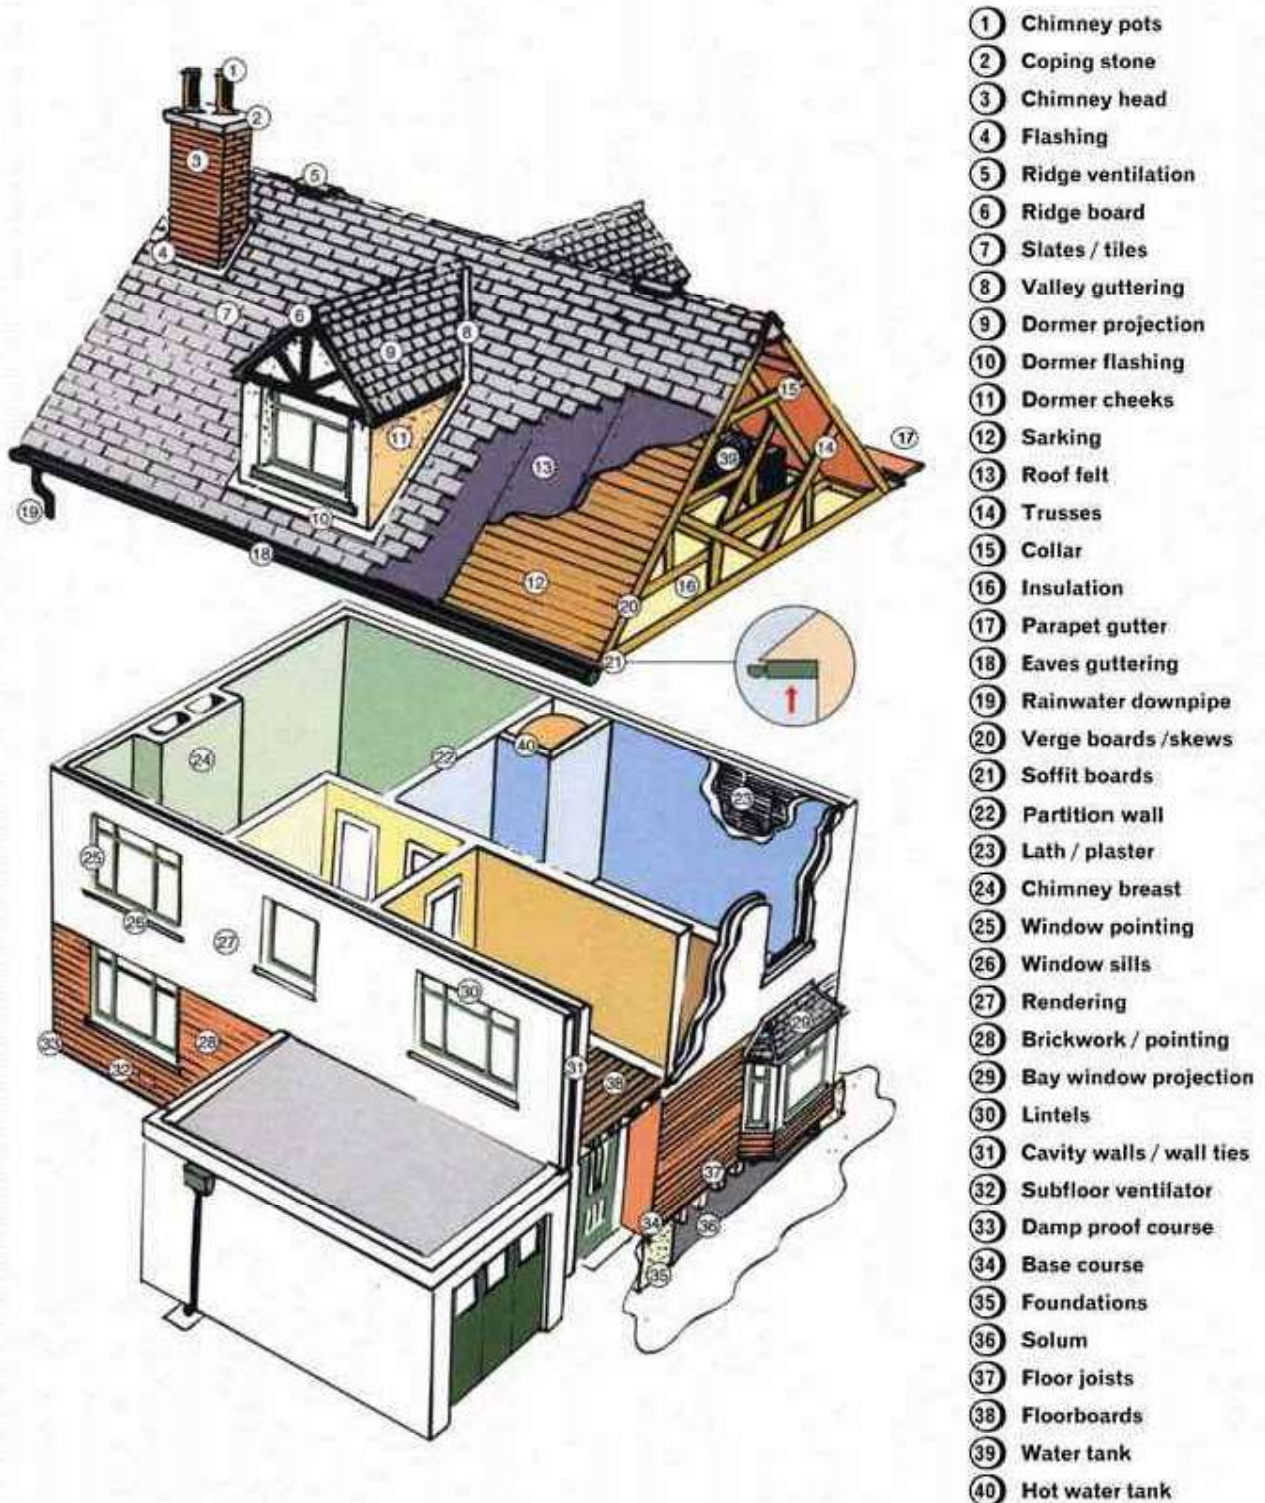
## Sectional Diagram showing elements of a typical house

Reference may be made in this report to some or all of the above component parts of the property. This diagram may assist you in locating and understanding these items.
