HOME
report

SINGLE SURVEY
ENERGY REPORT
PROPERTY QUESTIONNAIRE
VALUATION REPORT

Property address	207 Gordon's Mills Road, Aberdeen, AB24 2XS
-------------------------	---

Date of inspection	29th November 2021
---------------------------	--------------------

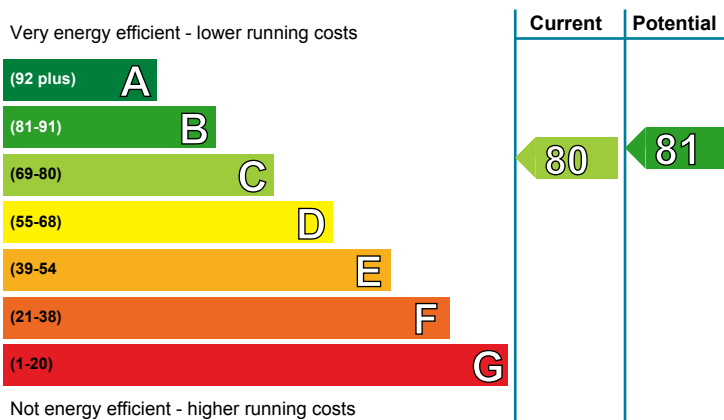
Energy Efficiency Rating

This graph shows the current efficiency of your home, taking into account both energy efficiency and fuel costs. The higher this rating, the lower your fuel bills are likely to be.

Your current rating is **band C (80)**. The average rating for EPCs in Scotland is **band D (61)**.

The potential rating shows the effect of undertaking all of the improvement measures listed within your recommendations report.

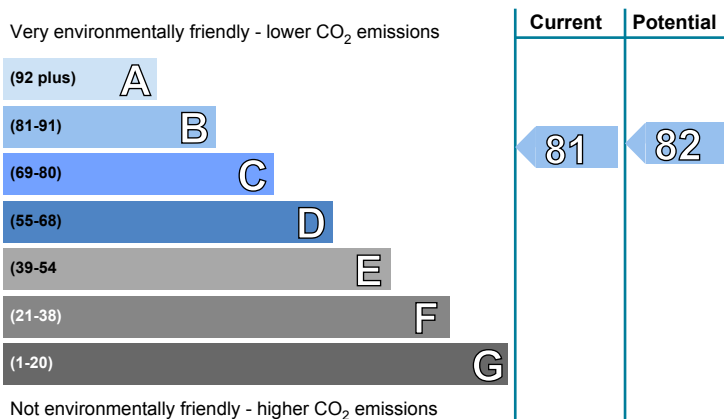
Environmental Impact (CO₂) Rating

This graph shows the effect of your home on the environment in terms of carbon dioxide (CO₂) emissions. The higher the rating, the less impact it has on the environment.
