FLAT C
101 ROSEMOUNT PLACE
ABERDEEN
AB25 2YG

Home Report

Energy Performance Certificate

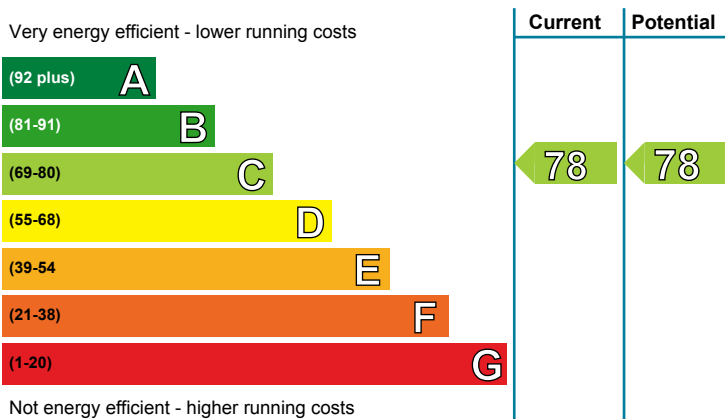
Energy Efficiency Rating

This graph shows the current efficiency of your home, taking into account both energy efficiency and fuel costs. The higher this rating, the lower your fuel bills are likely to be.

Your current rating is **band C (78)**. The average rating for EPCs in Scotland is **band D (61)**.

The potential rating shows the effect of undertaking all of the improvement measures listed within your recommendations report.
