HOME
report

SINGLE SURVEY
ENERGY REPORT
PROPERTY QUESTIONNAIRE
VALUATION REPORT

Single Survey

Property address	24 Beechgrove Place, Aberdeen, AB15 5HF
-------------------------	-----------------------------------------------

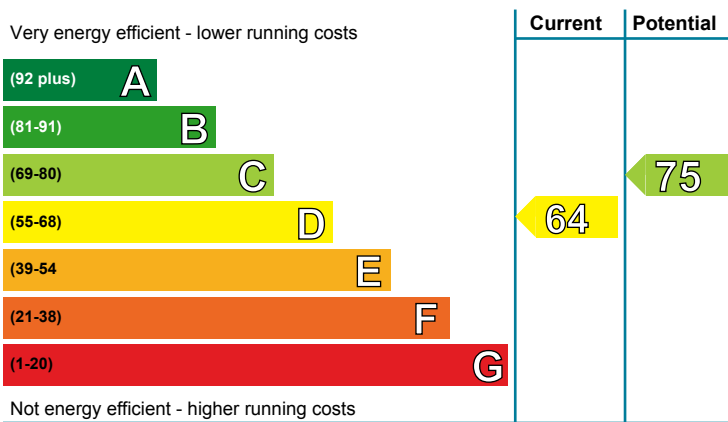
Energy Efficiency Rating

This graph shows the current efficiency of your home, taking into account both energy efficiency and fuel costs. The higher this rating, the lower your fuel bills are likely to be.

Your current rating is **band D (64)**. The average rating for EPCs in Scotland is **band D (61)**.

The potential rating shows the effect of undertaking all of the improvement measures listed within your recommendations report.

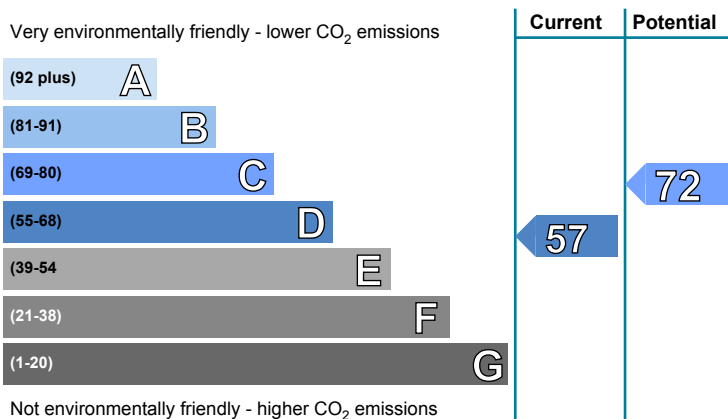
Environmental Impact (CO₂) Rating

This graph shows the effect of your home on the environment in terms of carbon dioxide (CO₂) emissions. The higher the rating, the less impact it has on the environment.
